APPENDIX.

CONTROL SITE PHOTOGRAPHS, VEGETATION COVER DATA AND SUMMARY ASSESSMENTS

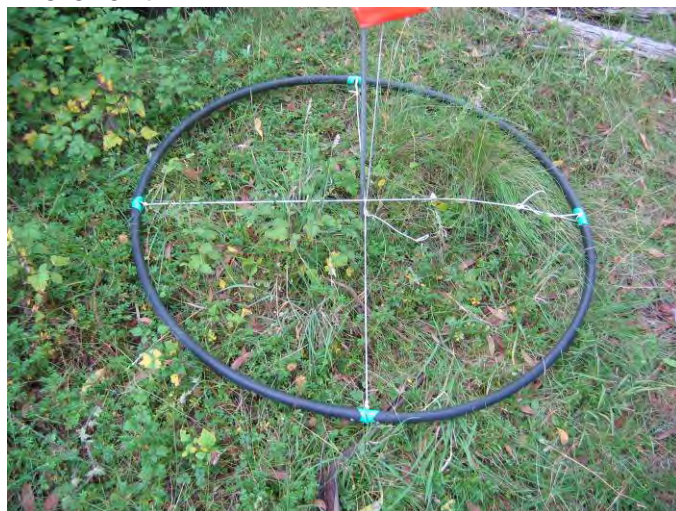
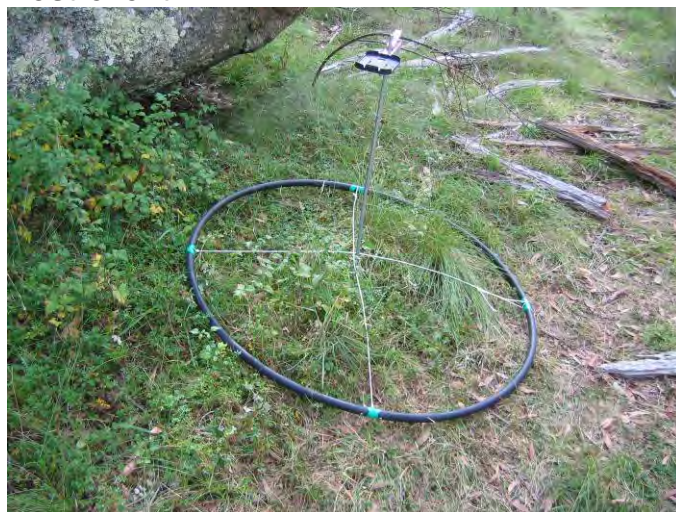
Control no: 106

Immediately following the event, there was some flattening of grass along the route past the control (mainly outside the quadrat) but no other impacts. Further monitoring was considered unnecessary.

Overall post-event impact: Minimal

Survey	Percentage cover					Comments
	Groundcover	Shrubs	Litter	Bare ground	Rock	
Pre-event	90	0	8	2	0	High groundcover (forbs/ grass)
Post-event	83	3	12	2	0	As above, minor trampling
One year						Not monitored

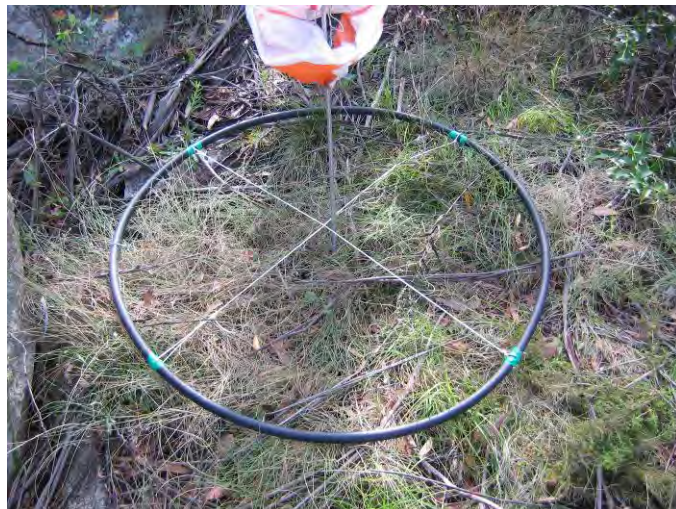
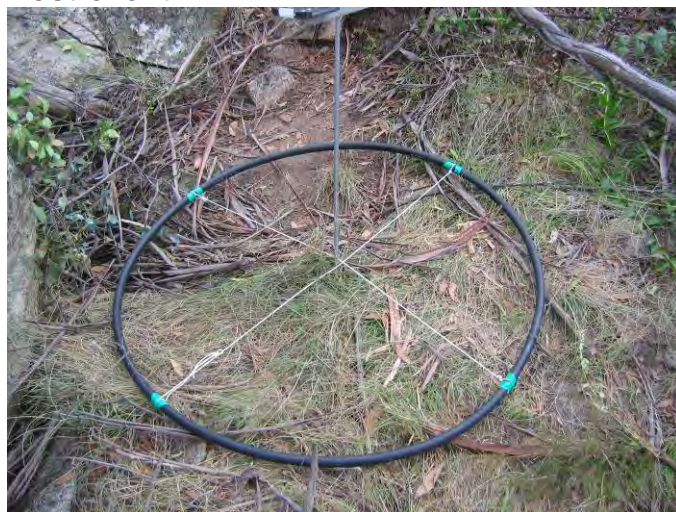
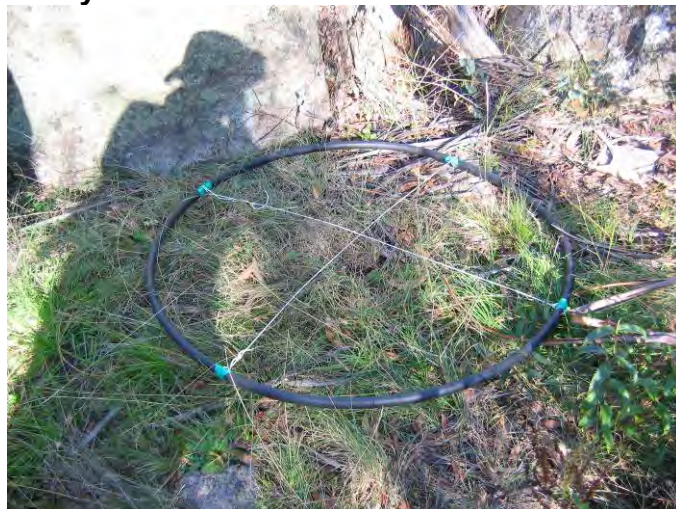
Control no. 114

There was some increase in bare ground following the event and an increase in litter cover, possibly due to litter movement from outside the quadrat. The increase in bare ground was more evident outside the quadrat. There was also obvious trampling of the grass.

After one year the groundcover had largely recovered with the areas of litter cover and bare ground reduced.

Overall post-event impact: Moderate
Overall one-year impact: Minor

Survey	Percentage cover					Comments
	Groundcover	Shrubs	Litter	Bare ground	Rock	
Pre-event	83	0	12	3	2	High groundcover, minor litter cover
Post-event	57	0	31	12	0	Some tussock trampled
One year	72	0	21	5	2	High groundcover, low litter cover, bare ground recovered

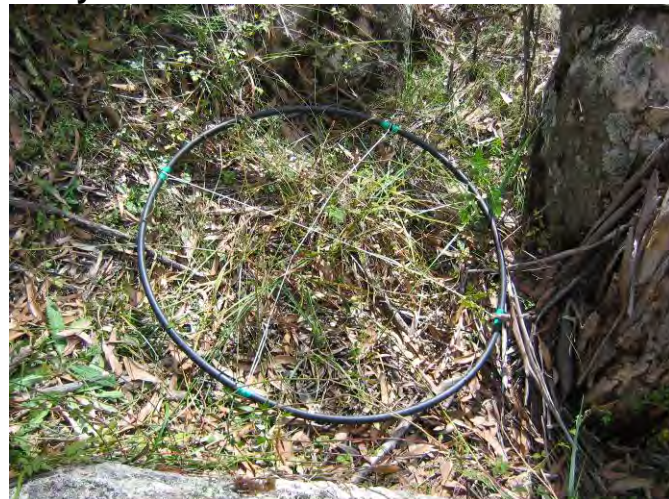
Control no: 116

Litter appeared to have moved downslope, covering groundcover and exposing an area of bare ground just outside the quadrat (not indicated in numerical results but visible in photograph). A native raspberry plant had gone. After one year, there was regrowth of the native raspberry and a thin cover of litter over the bare ground outside the quadrat.

Overall post-event impact: Moderate

Overall one-year impact: Minor

Survey	Percentage cover					Comments
	Groundcover	Shrubs	Litter	Bare ground	Rock	
Pre-event	24	7	65	4	0	Native raspberry present
Post-event	9	1	86	4	0	Native raspberry damaged, litter trampled
One year	11	<1	86	3	0	Native raspberry regenerating, bare ground recovered/ unchanged

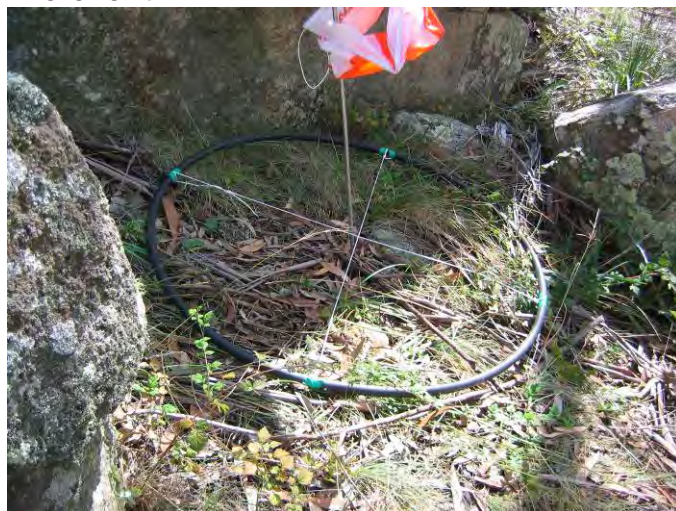
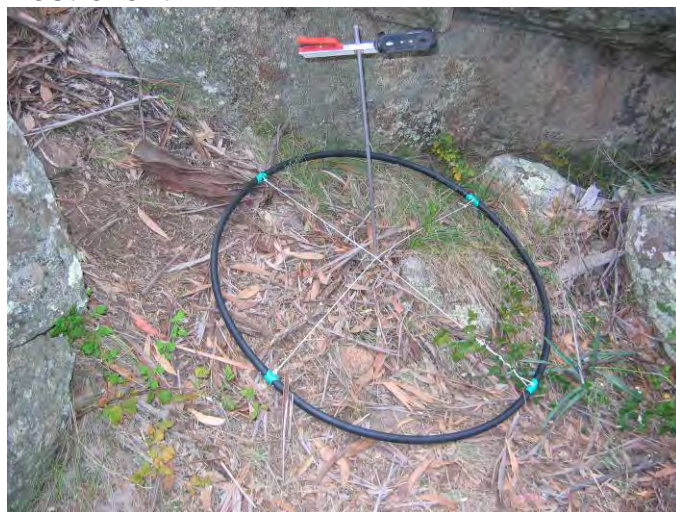
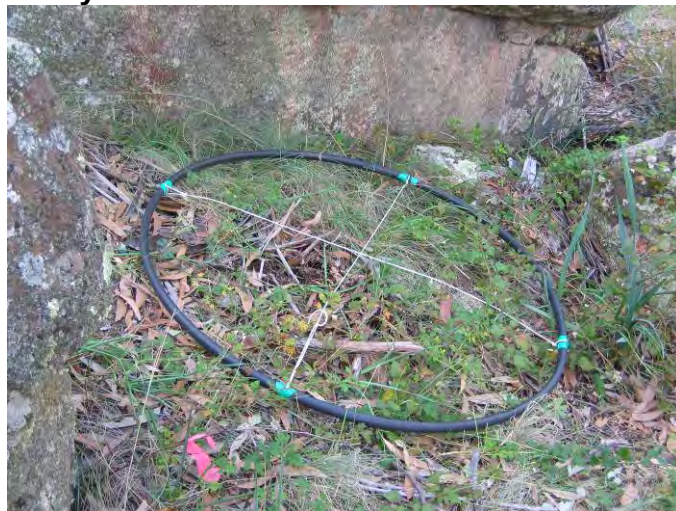
Control no: 117

Litter and small rocks had moved downhill within the quadrat. There was not much change within the quadrat, although the litter was flattened and the area of bare ground outside the quadrat increased. This bare ground was covered with leaf litter after one year. Lichen on the rock remained intact.

Overall post-event impact: Major
Overall one-year impact: Negligible

Survey	Percentage cover					Comments
	Groundcover	Shrubs	Litter	Bare ground	Rock	
Pre-event	27	4	47	9	13	Small rocks 80-90% lichen
Post-event	28	1.5	58	3.5	9	No lichen damage, minor rock exposed
One year	56	0	37	1	6	Native raspberry growth, native ground lily growth

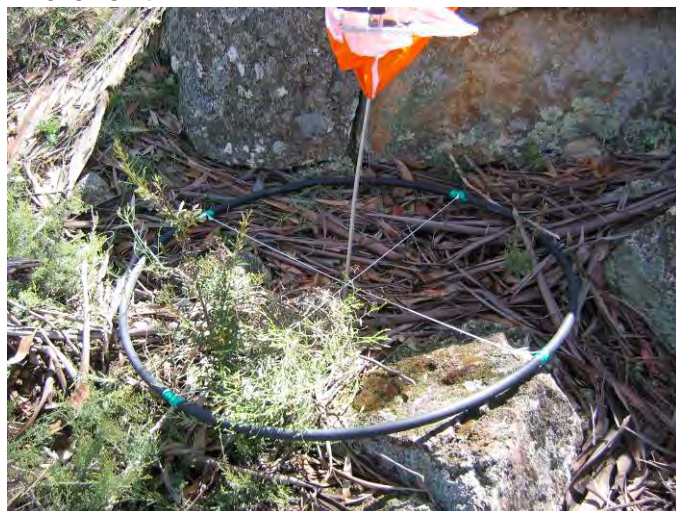
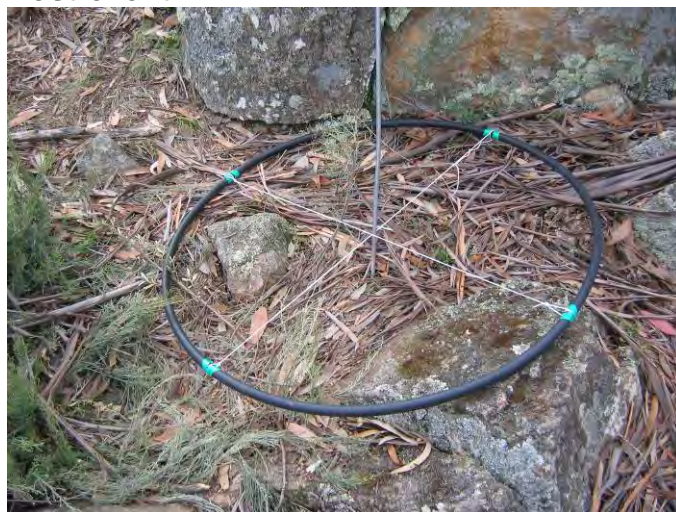
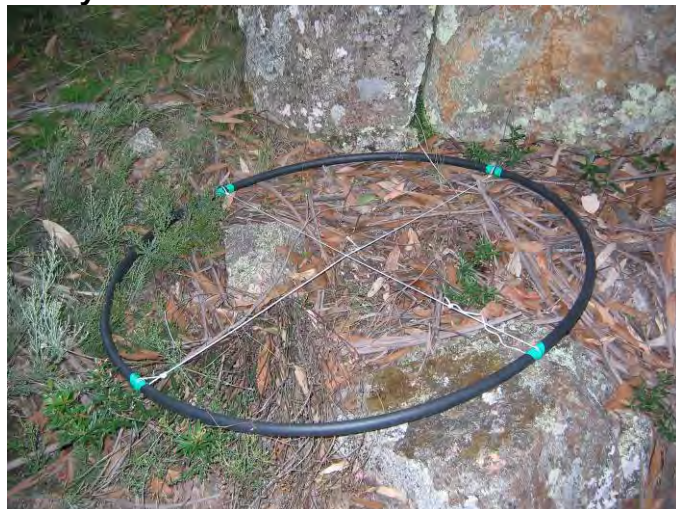
Control no: 120

There was some heath damage near the control and particularly downslope of the control (outside the quadrat), exposing areas of rock. Lichen on the rock remained intact.

After one year, there was partial recovery of the heath, although much of the disturbed area was covered with litter.

Overall post-event impact: Major
Overall one-year impact: Minor

Survey	Percentage cover					Comments
	Groundcover	Shrubs	Litter	Bare ground	Rock	
Pre-event	3	11	63	2	21	Rock 90-100% lichen
Post-event	1	1	67	2	29	Lichen intact, no shrub damage
One year	1	4	81	<1	14	Increased litter

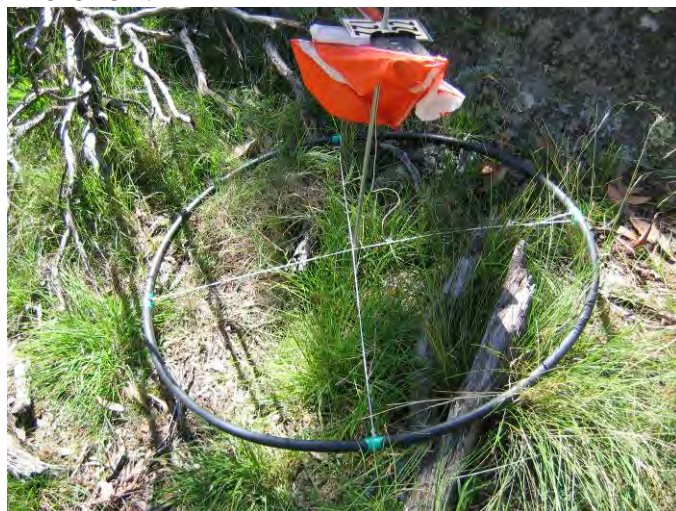
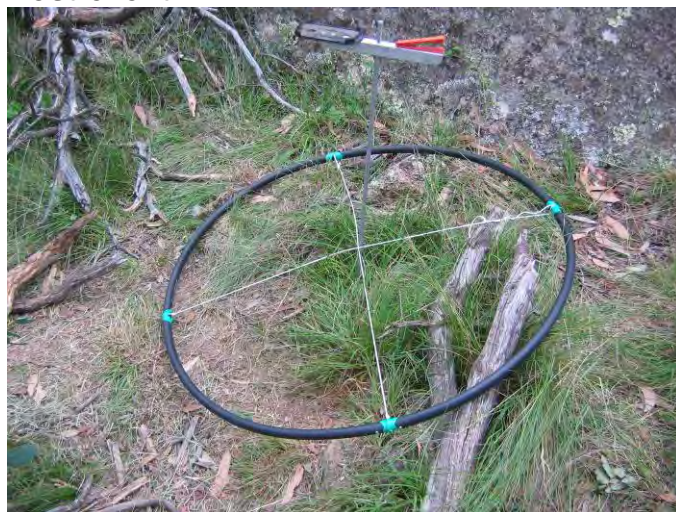
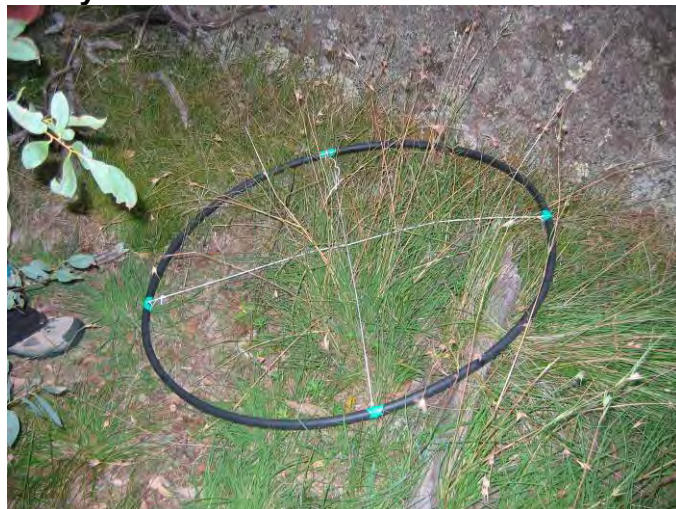
Control no: 122

There was an increase in bare ground immediately following the event, mainly as a result of reduced litter cover. This was evident both within the quadrat and outside it on the exit route.

After one year, the area of bare ground was reduced but it was still evident. There was increased regeneration of groundcover, mainly *Themeda*.

Overall post-event impact: Major

Overall one-year impact: Minor

Survey	Percentage cover					Comments
	Groundcover	Shrubs	Litter	Bare ground	Rock	
Pre-event	55	0	32	5	8	Lichen on rock 85% Minor bare ground
Post-event	62	<1	16	16	6	No lichen damage. Some new bare ground
One year	83	<1	3	12	2	<i>Olearia erubescens</i> 30 cm, ? new growth

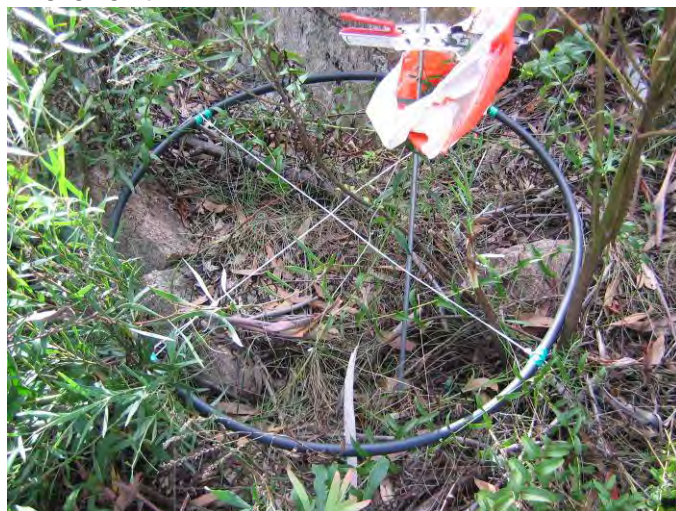
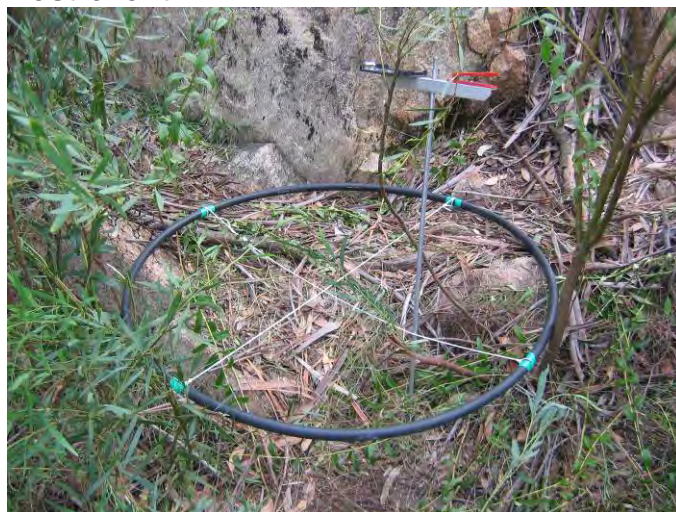
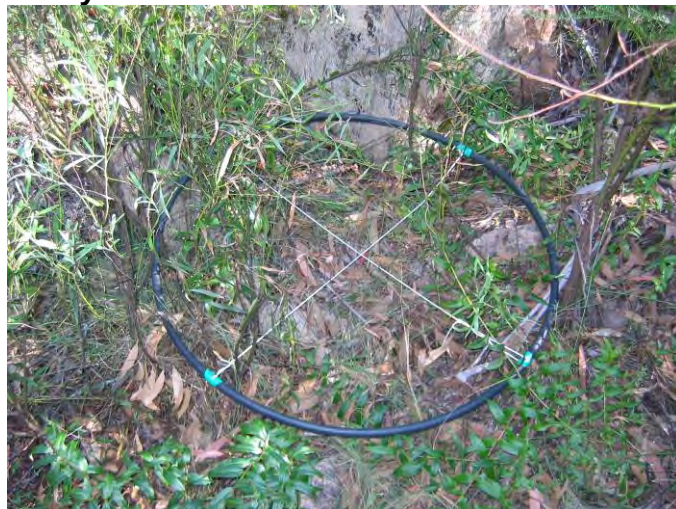
Control no: 123

Immediately following the event a small increase in bare ground due to litter loss was evident within the quadrat. More extensive litter disturbance was evident outside the quadrat, downslope on the exit route from the control.

After one year, this bare ground was covered with litter or groundcover, and there was further development of groundcover and shrubs in some of the litter areas.

Overall post-event impact: Moderate

Overall one-year impact: Minor

Survey	Percentage cover					Comments
	Groundcover	Shrubs	Litter	Bare ground	Rock	
Pre-event	11	6	63	6	14	<i>Daviesia</i> shrub to 1.4 m
Post-event	10	4	55	14	17	Groundcover pressed down Shrub growth undamaged
One year	32	8	40	9	11	Shrub growth maintained Increased groundcover

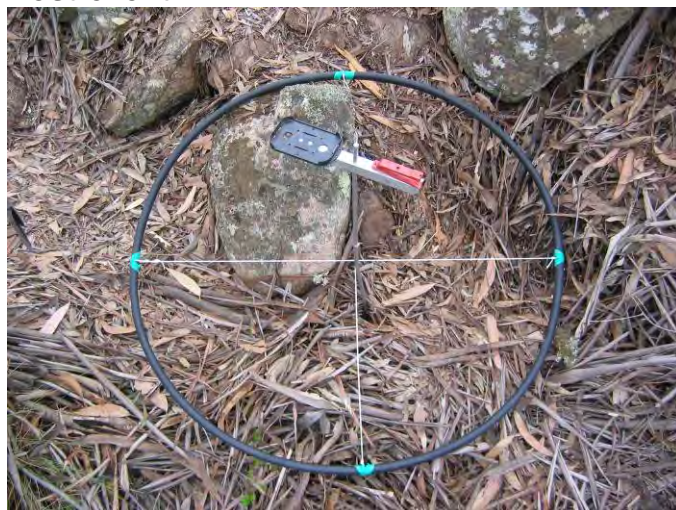
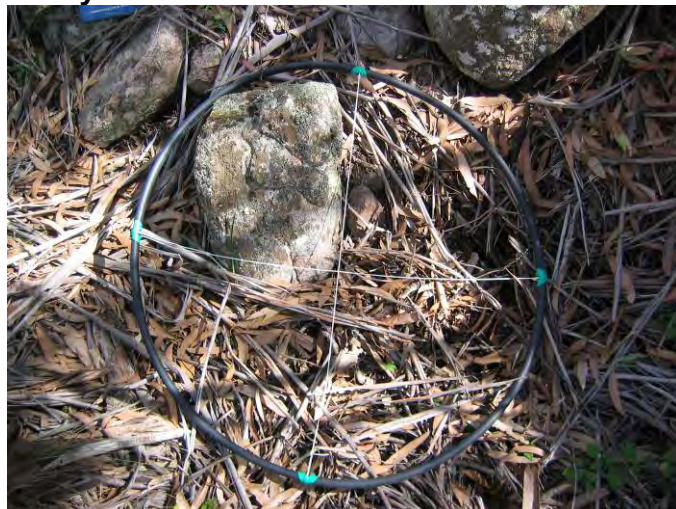
Control no: 128

This site was completely covered with litter prior to the event. That litter was trampled but remained generally intact, except for a small amount of bare ground. Minor lichen damage occurred on the rock. A deep litter cover had developed one year after the event.

There was obvious tracking down the hill into the control immediately after the event but this was not evident after one year.

Overall post-event impact: Minor
Overall one-year impact: Negligible

Survey	Percentage cover					Comments
	Groundcover	Shrubs	Litter	Bare ground	Rock	
Pre-event	0	1	78	0	21	Rock with 85% lichen. High litter cover
Post-event	0	0	73	3	24	Slight litter cover. Lichen intact
One year	0	0	80	0	20	As for pre-event assessment

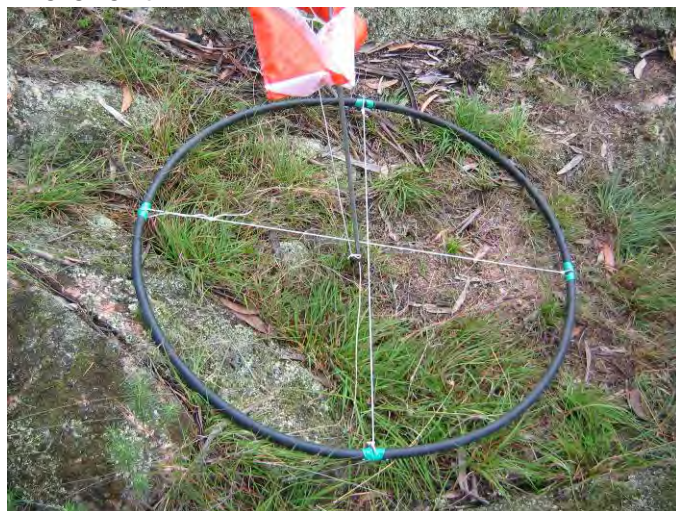
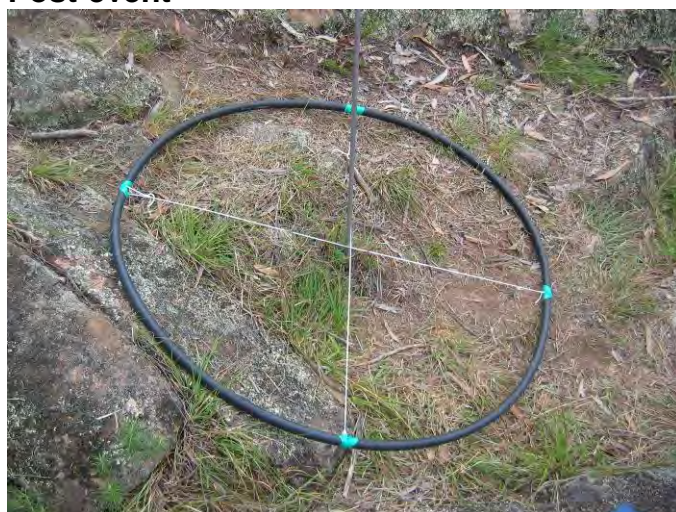
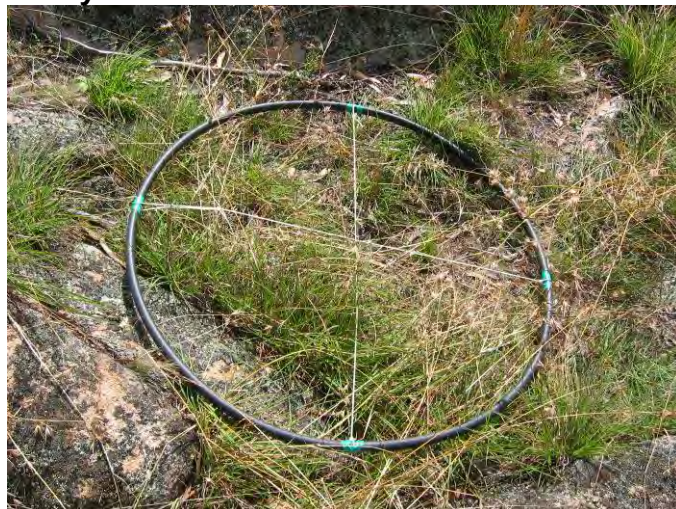
Control no: 129

There was obvious grass flattening on the routes in and out of the control following the event which resulted in a reduction in the area of groundcover and an increase in litter. Some small areas of bare ground developed just outside the circular quadrat. There was possibly some grass damage. There was minor damage to lichen on the rocks within the site, but most lichen remained intact.

After one year the grass had recovered, largely covering the bare spots, and the condition of the site was very similar to that prior to the event.

Overall post-event impact: Moderate
Overall one-year impact: Negligible

Survey	Percentage cover					Comments
	Groundcover	Shrubs	Litter	Bare ground	Rock	
Pre-event	51	0	6	24	19	Loose soil. Rock all lichen-covered
Post-event	30	0	21	26	23	Moderate trampling. Minor lichen damage
One year	54	0	6	20	20	Good <i>Themeda</i> growth. Minor lichen damage

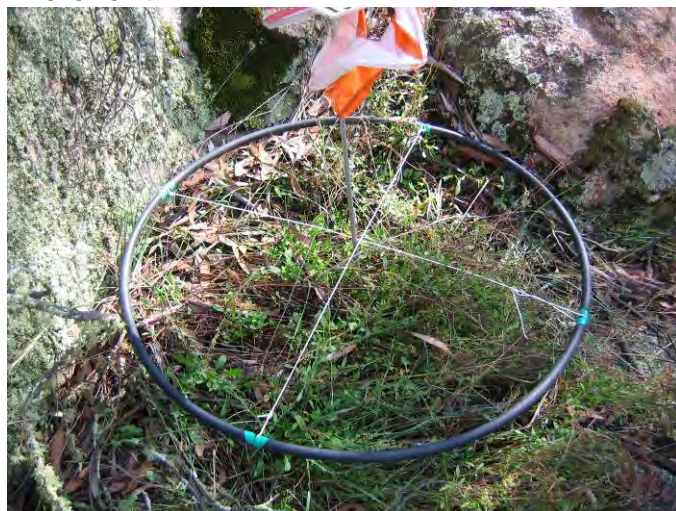
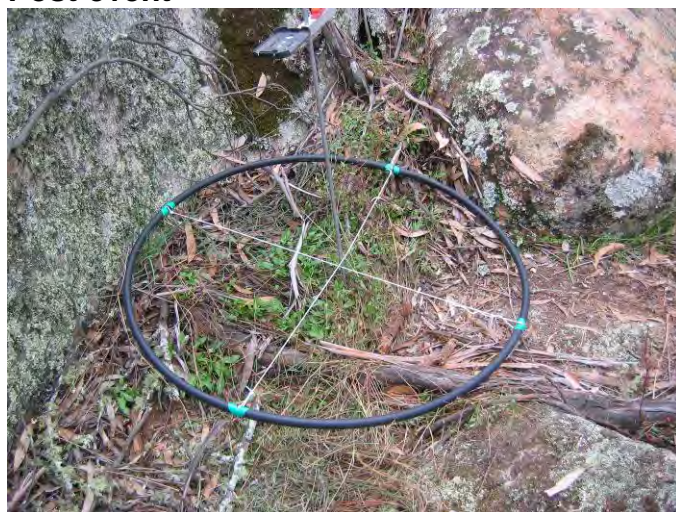
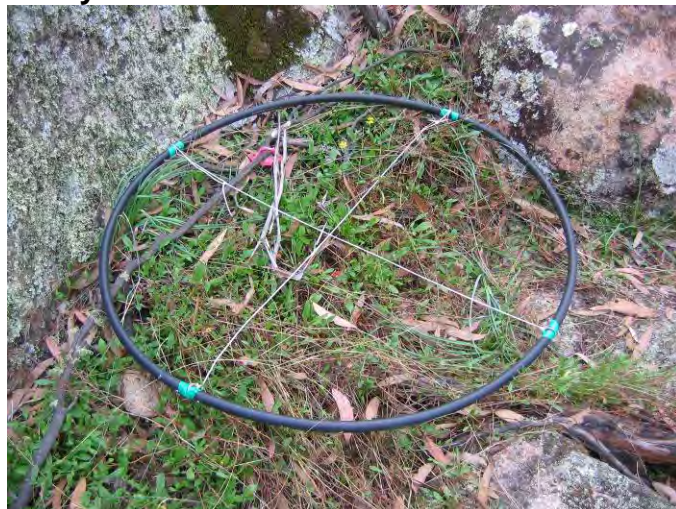
Control no: 132

The groundcover (grass) was flattened on the route out of the control and there was some movement of litter and a minor increase in bare ground. A large fallen branch had been moved into the quadrat.

After one year, there was dense regeneration of grass and forbs (especially sorrel) in areas of litter and bare ground.

Overall post-event impact: Moderate
Overall one-year impact: Negligible

Survey	Percentage cover					Comments
	Groundcover	Shrubs	Litter	Bare ground	Rock	
Pre-event	56	0	41	3	0	Good groundcover
Post-event	36	0	57	4	3	Branch moved, some trampling
One year	66	0	32	1	1	Forb cover (sheep sorrel)

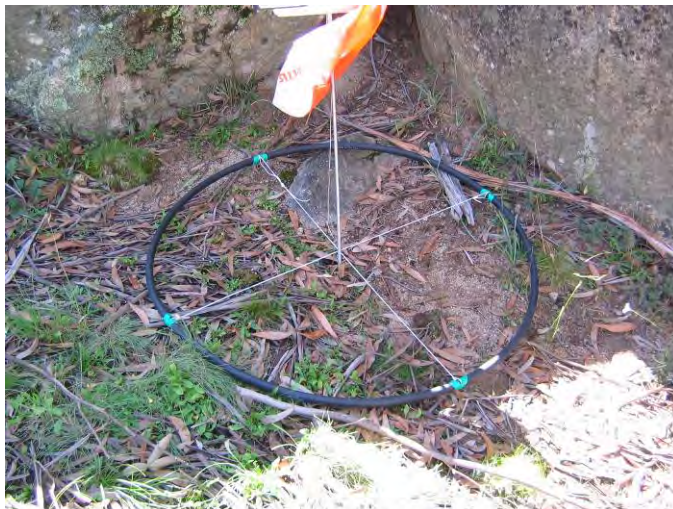
Control no: 133

This was one of the more disturbed control sites immediately following the event, with a significant increase in bare ground within areas of litter or groundcover, both within and outside the quadrat, some flattening of grass, and movement of sticks.

After one year, however, there was a light cover of leaf litter over most of the bare ground, and further movement of the sticks. Some disturbance of the site unrelated to the orienteering event occurred during that period as the marker peg had been pulled out and a stick with flagging tape had been broken.

Overall post-event impact: Major
Overall one-year impact: Minor

Survey	Percentage cover					Comments
	Groundcover	Shrubs	Litter	Bare ground	Rock	
Pre-event	8	0	44	40	8	Coarse loose soil. Bark/ leaf litter
Post-event	2.5	0	31	60	6.5	
One year	3	0	77	15	5

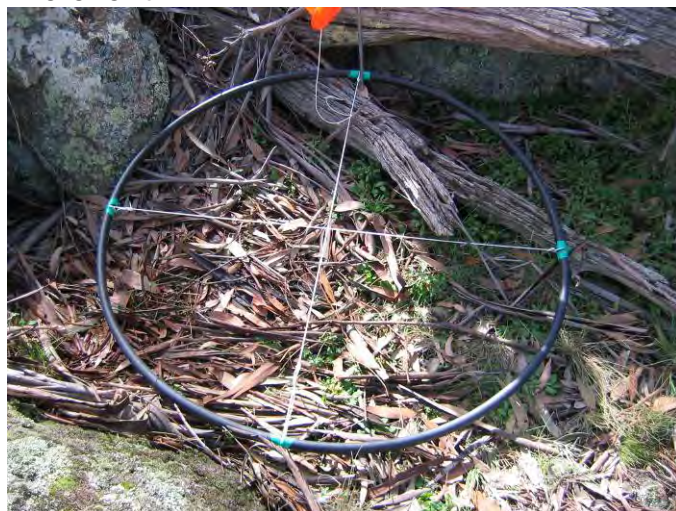
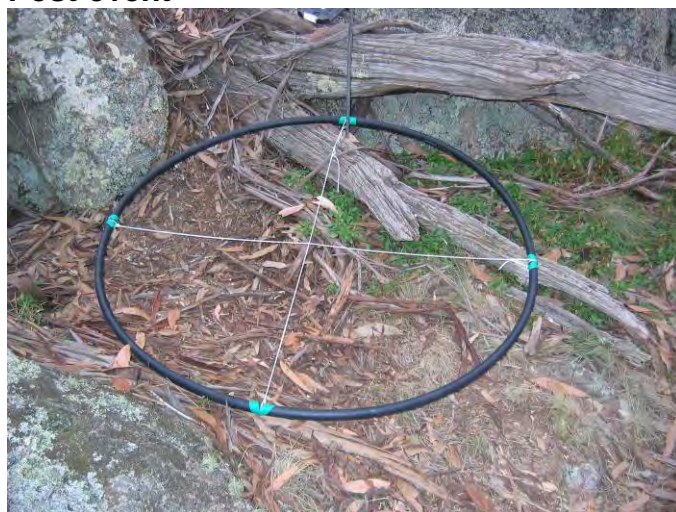
Control no: 134

Immediately after the event, the area of bare ground was increased due to loss of litter. Elsewhere the litter or grass was flattened, with some grass exposed possibly due to litter movement. Some flattening occurred also downhill of the control but this was relatively minor.

After one year, fresh litter had accumulated to eliminate the bare ground, and some grass and sorrel had regenerated.

Overall post-event impact: Moderate
Overall one-year impact: Negligible

Survey	Percentage cover					Comments
	Groundcover	Shrubs	Litter	Bare ground	Rock	
Pre-event	14	0	81	5	0	Coarse heavy litter, heavy wood
Post-event	19	0	69	12	0	Some slight trampling. Increased new bare ground
One year	39	0	59	2	0	Large wood still in place

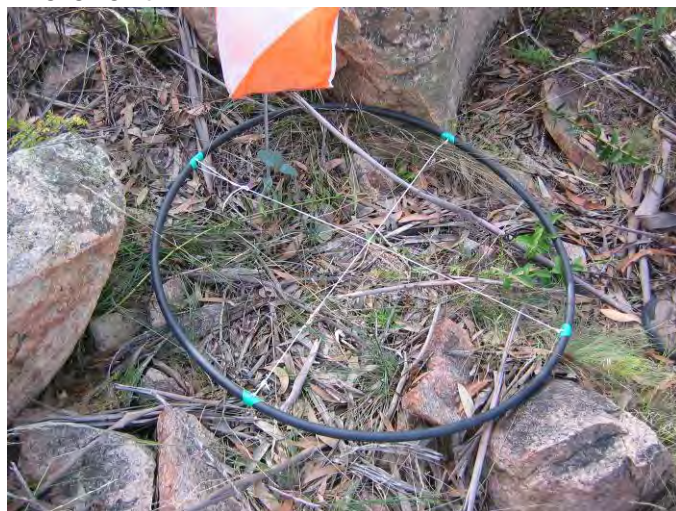
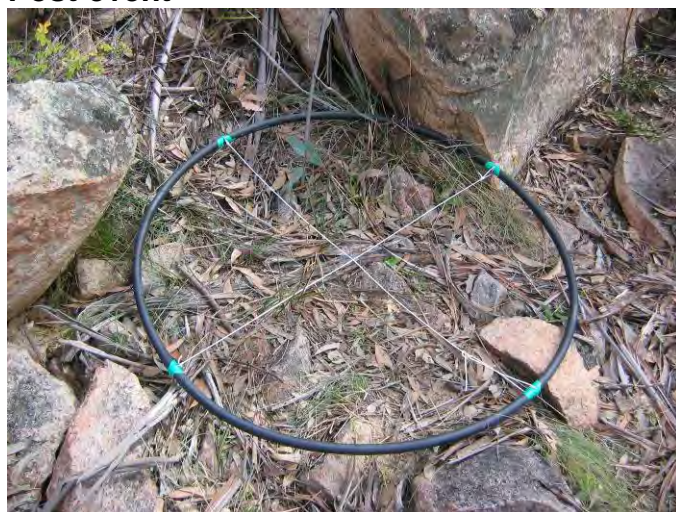
Control no: 138

The litter was flattened immediately after the event, but otherwise there was not much impact. Further monitoring was considered unnecessary.

Overall post-event impact: Minor

Survey	Percentage cover					Comments
	Groundcover	Shrubs	Litter	Bare ground	Rock	
Pre-event	11	1	69	2	17	Leafy litter, no rock or lichen
Post-event	7	0	71	5	17	No disturbance
One year						Not monitored

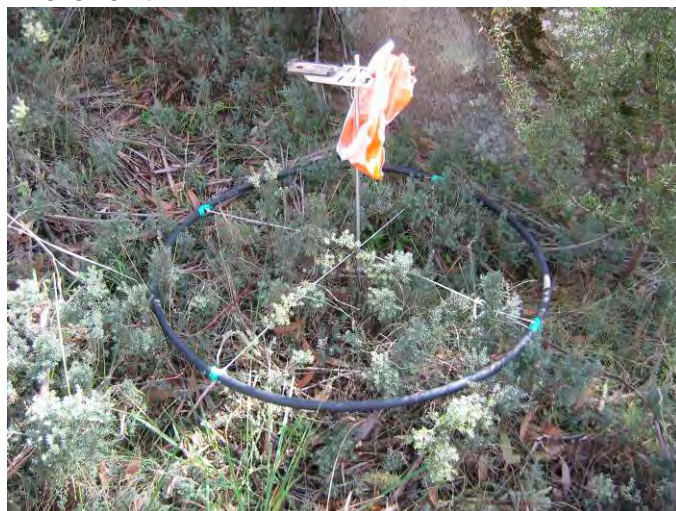
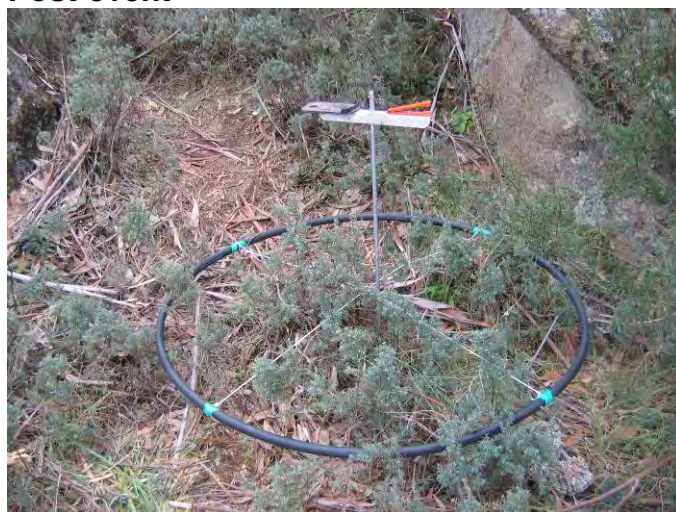
Control no: 144

Very minor damage occurred to the *Leucopogon* low shrub and litter and groundcover outside the quadrat was flattened, but there was a generally low level of impact immediately after the event.

The flattened area accumulated litter after one year and there was regeneration of groundcover. Otherwise not much further change was evident.

Overall post-event impact: Minor
Overall one-year impact: Negligible

Survey	Percentage cover					Comments
	Groundcover	Shrubs	Litter	Bare ground	Rock	
Pre-event	29	33	29	9	0	<i>Leucopogon hookeri</i> (low shrub) present
Post-event	14	23	57	5	1	No trampling
One year	35	19	45	1	0	As above

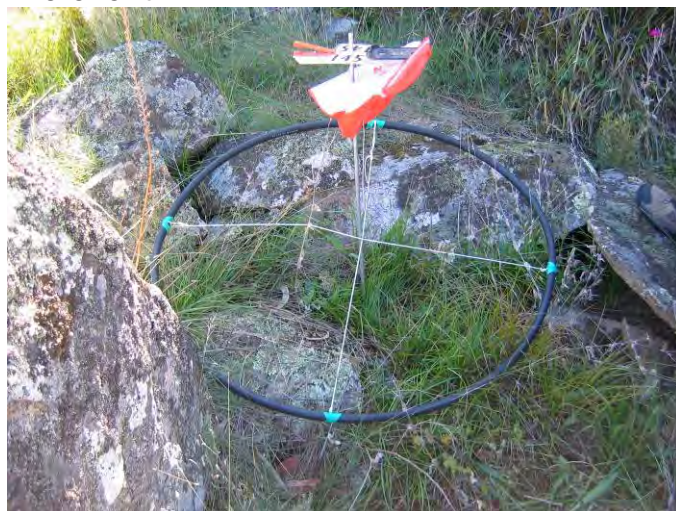
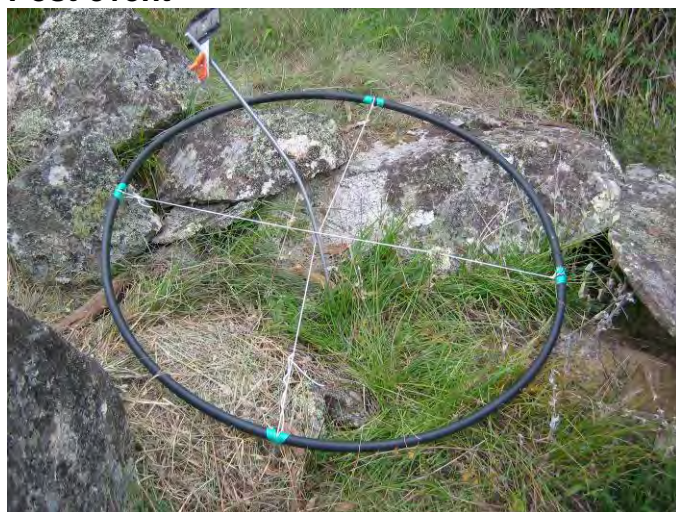
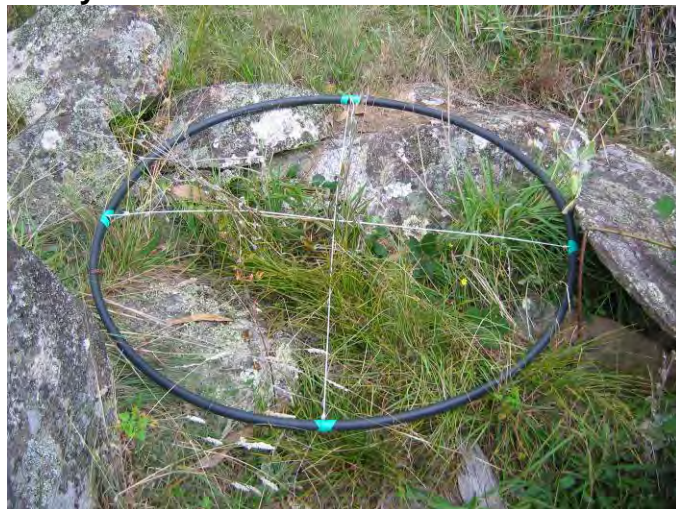
Control no: 145

The grass around the control was flattened but otherwise not damaged during the event, resulting in a rock being covered with thatch (measured as litter). Similar impacts were noted on the routes into and out of the control.

The situation was reversed after one year, with the grass regenerating and the rock becoming exposed. A stem of blackberry had grown over the control site from outside.

Overall post-event impact: Moderate
Overall one-year impact: Negligible

Survey	Percentage cover					Comments
	Groundcover	Shrubs	Litter	Bare ground	Rock	
Pre-event	39	0	2.5	2.5	56	Rock with 70-90% lichen
Post-event	28	0	31	6	35	Grass flattened, no lichen damage
One year	37	0	1.5	0.5	61	Blackberry present

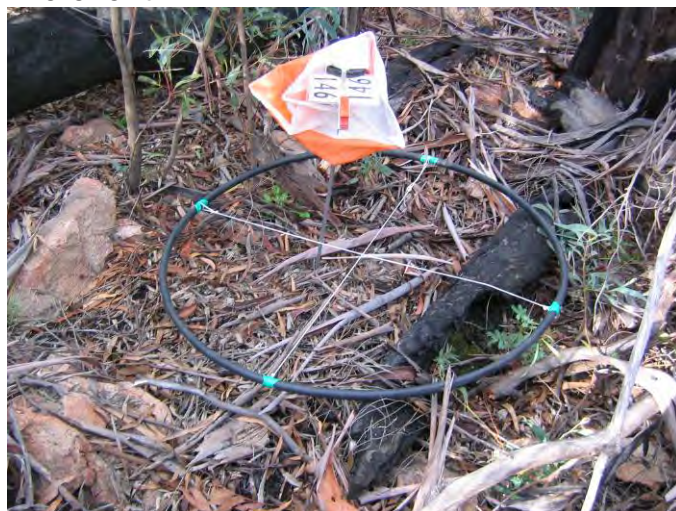
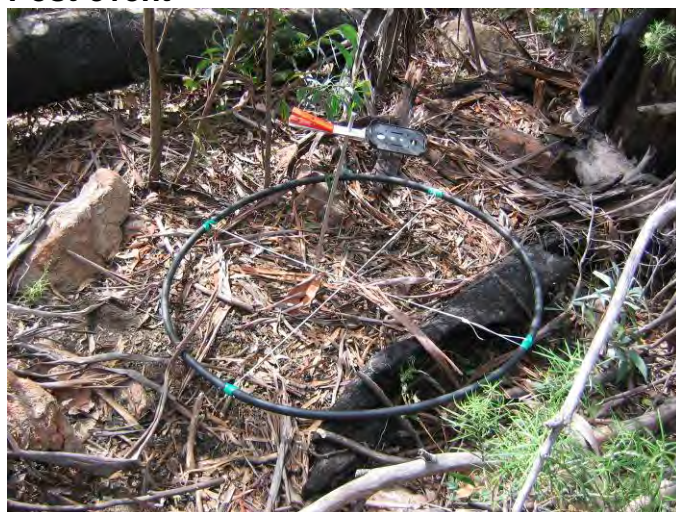
Control no: 146

Immediately following the event, there was some increase in bare ground, within and outside the quadrat due to litter disturbance. Elsewhere the litter was flattened, but remained in place.

After one year, the litter cover was restored with leaves and bark. A new wattle seedling had grown within the quadrat.

Overall post-event impact: Minor
Overall one-year impact: Negligible

Survey	Percentage cover					Comments
	Groundcover	Shrubs	Litter	Bare ground	Rock	
Pre-event	<1	1	95	4	0	<i>Daviesia</i> shrub to 0.3 m
Post-event	0	<1	76	20	4	<i>Daviesia</i> shrub undisturbed
One year	1	2	93	1	3	New wattle seedling

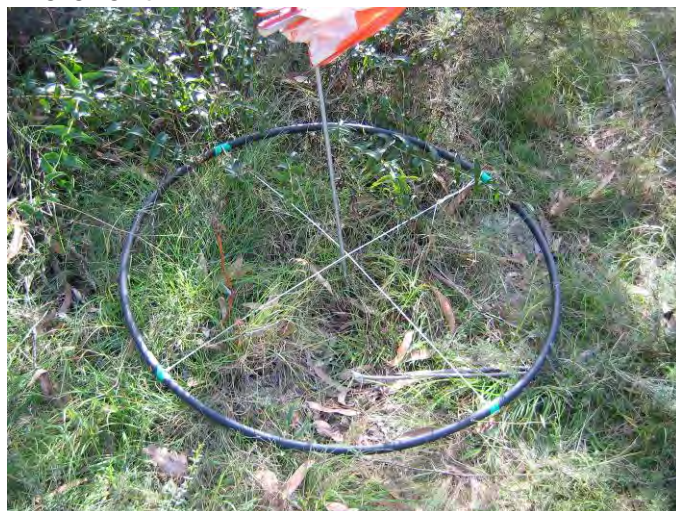
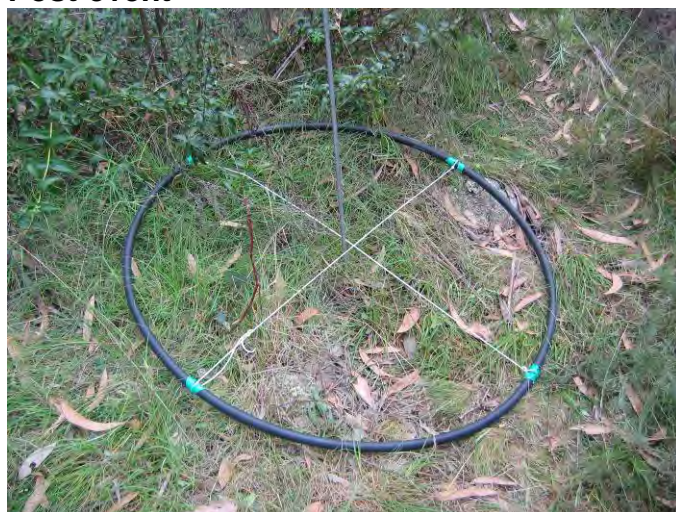
Control no: 147

Apart from some flattening of grass, no post-event impact was evident. Further monitoring was considered unnecessary.

Overall post-event impact: Minimal

Survey	Percentage cover					Comments
	Groundcover	Shrubs	Litter	Bare ground	Rock	
Pre-event	81	2	9	4	4	<i>Derwentia</i> 'shrub' < 0.5 m
Post-event	81	2	12	3	2	<i>Derwentia</i> not trampled
One year						Not monitored

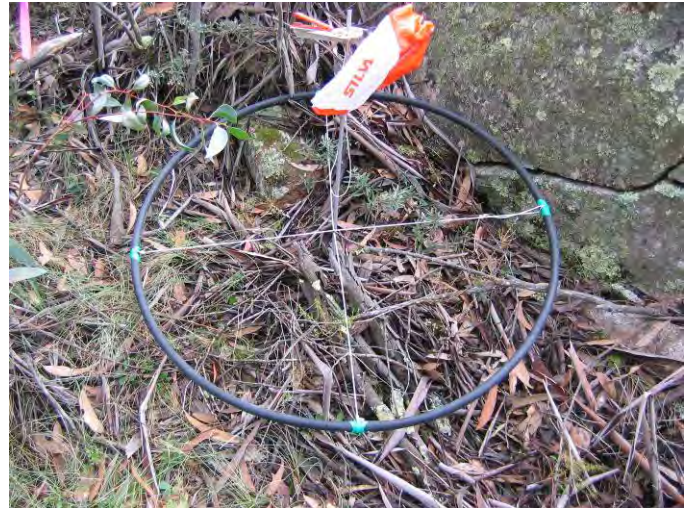
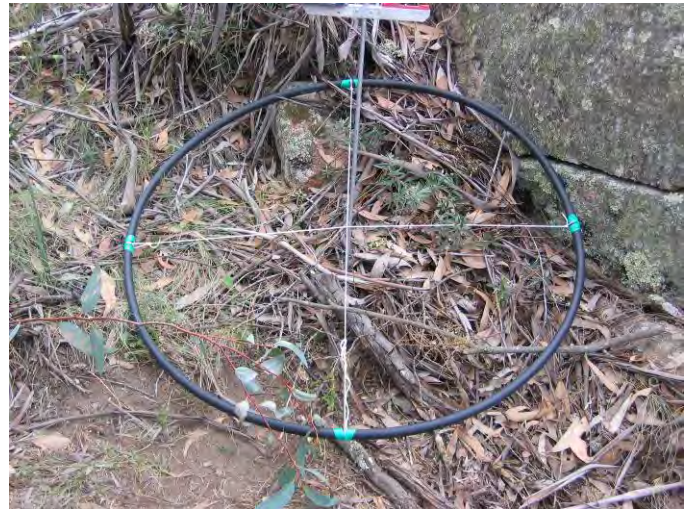
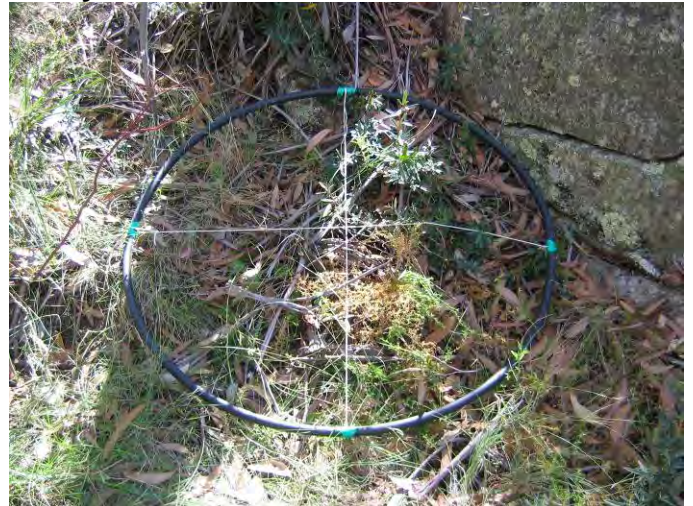
Control no: 148

There was an increase in bare ground, but this was virtually all in an area that was previously litter. Some of the litter was scattered over an area that was previously rock. Lichen on the rocks remained largely intact. Some of the bare ground and litter areas were covered with grass after one year, with litter redistributed over most of the rocks.

Litter was flattened near the drinks located downhill of the control, but maintained its cover. That area remained covered with litter after one year.

Overall post-event impact: Moderate
Overall one-year impact: Negligible

Survey	Percentage cover					Comments
	Groundcover	Shrubs	Litter	Bare ground	Rock	
Pre-event	2	2	79	3	14	80% lichen on rock
Post-event	7	2	72	15	4	Some lichen flaked off, but mainly intact
One year	17	7	74	1	1	Good litter cover

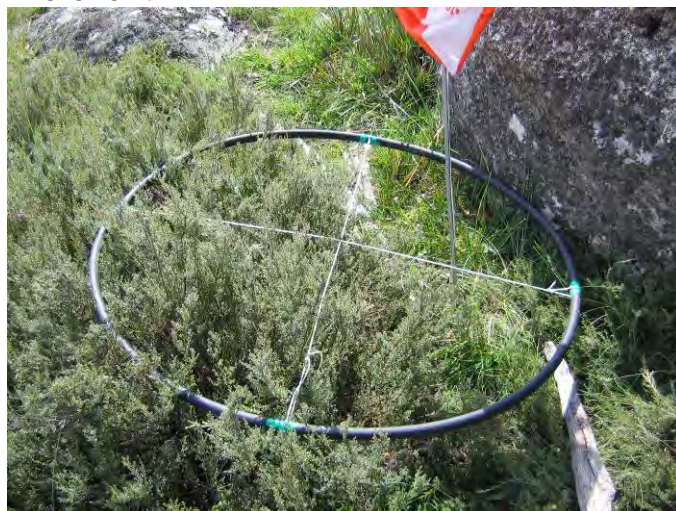
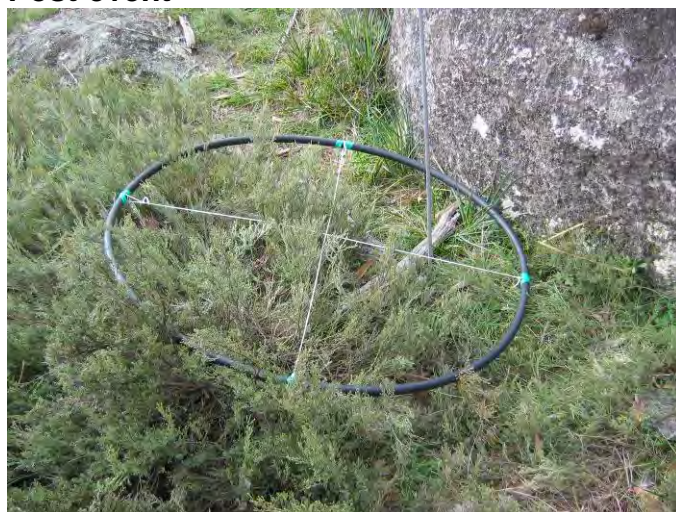
Control no: 155

The main impact immediately following the event was partial flattening of the heath. This impact was less severe than at some other controls, and the heath appeared to have recovered fully after one year.

Overall post-event impact: Moderate
Overall one-year impact: Negligible

Survey	Percentage cover					Comments
	Groundcover	Shrubs	Litter	Bare ground	Rock	
Pre-event	26	64	9	1	0	<i>Mirbelia</i> low shrub dominant
Post-event	32	56	10	<1	1	Heath flattening (partial)
One year	28	65	3	4	0

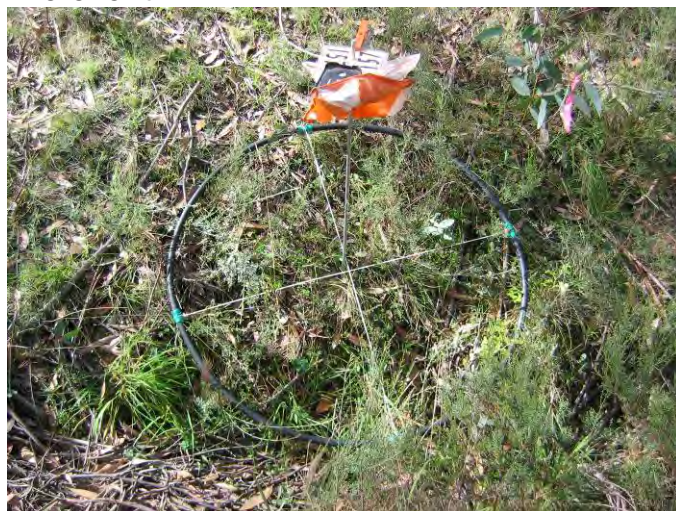
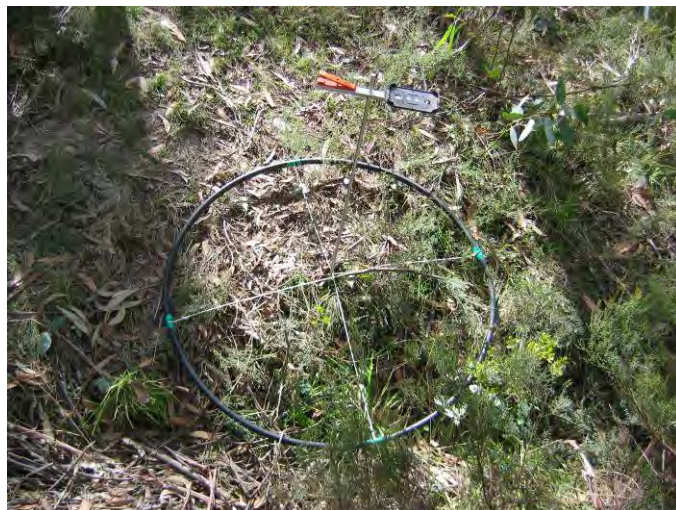
Control no: 157

Immediately after the event there was much flattening of the low heath (*Mirbelia*), as well as disturbance of litter to create bare ground, mainly outside the quadrat.

The flattened heath had fully recovered after one year, and the areas of bare ground had acquired a light cover of litter.

Overall post-event impact: Moderate
Overall one-year impact: Negligible

Survey	Percentage cover					Comments
	Groundcover	Shrubs	Litter	Bare ground	Rock	
Pre-event	39	17	39	5	0	Low <i>Mirbelia</i> shrub, grassy
Post-event	34	11	49	6	0	Some <i>Mirbelia</i> shrub trampled
One year	79	3	17	1	0

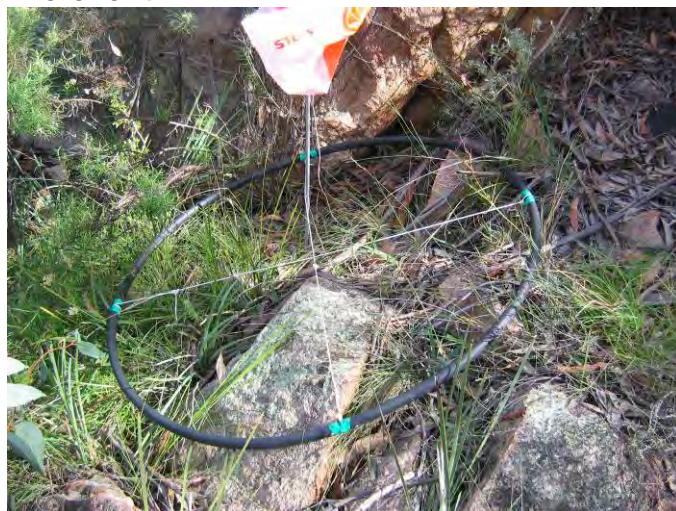
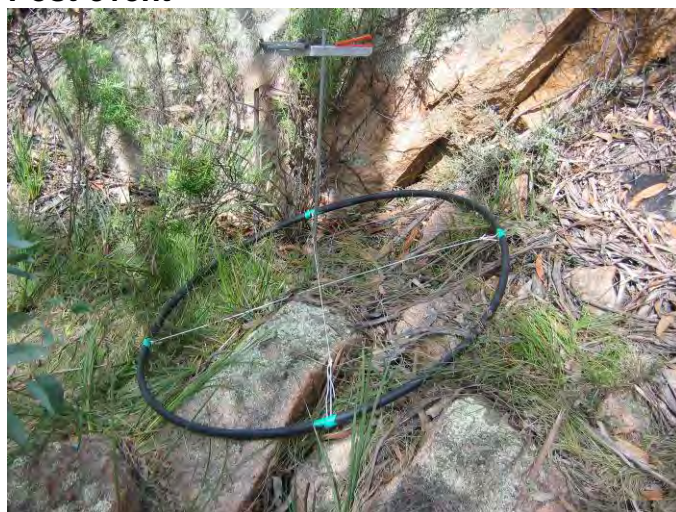
Control no: 161

Immediately following the event, the grass was flattened around the control, increasing the exposure of the rocks, but otherwise there was no impact. Some litter disturbance was evident 3 to 4 metres from the control. Further monitoring was considered unnecessary.

Overall post-event impact: Minor

Survey	Percentage cover					Comments
	Groundcover	Shrubs	Litter	Bare ground	Rock	
Pre-event	34	0	31	16	19	90% lichen on rock. Low <i>Cassinia</i> shrub
Post-event	27	3	32	4	34	No lichen damage. <i>Cassinia</i> intact
One year						Not monitored

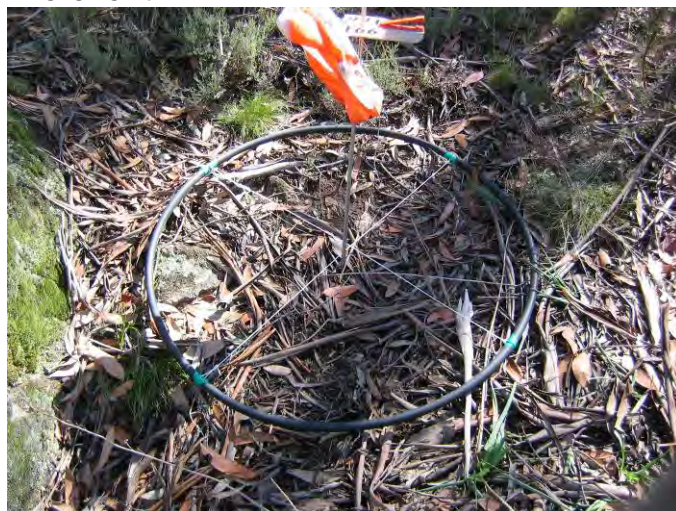
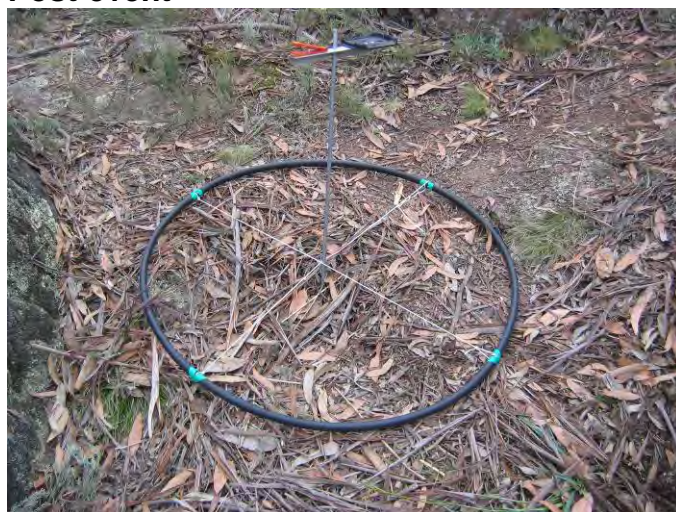
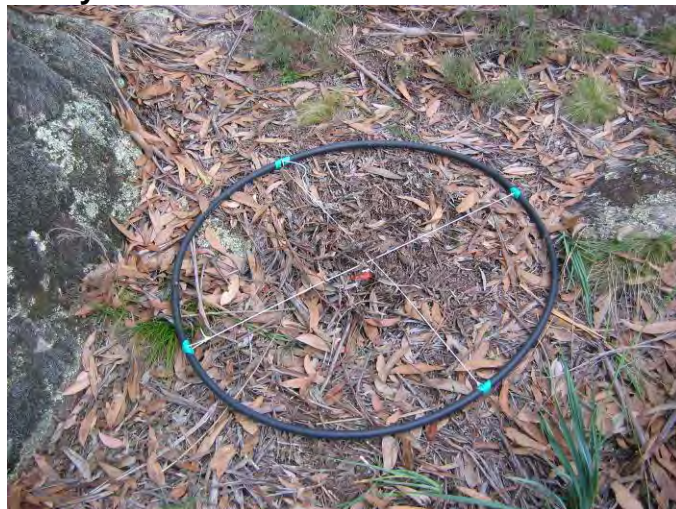
Control no: 166

During the event, litter was pushed from upslope of the control (outside the quadrat) to cover some bare ground and rock within the quadrat, and expose bare ground outside it. There was no disturbance downhill of the control, suggesting that runners generally arrived and departed from above.

After one year, all of the exposed bare ground had been covered with leaf litter.

Overall post-event impact: Moderate
Overall one-year impact: Negligible

Survey	Percentage cover					Comments
	Groundcover	Shrubs	Litter	Bare ground	Rock	
Pre-event	<1	0	82	14	4	Small rocks, 70-90% lichen cover. Loose soil
Post-event	<1	0	92	7	1	Lichen intact, loose litter moved around
One year	0.5	0	98	1.5	0

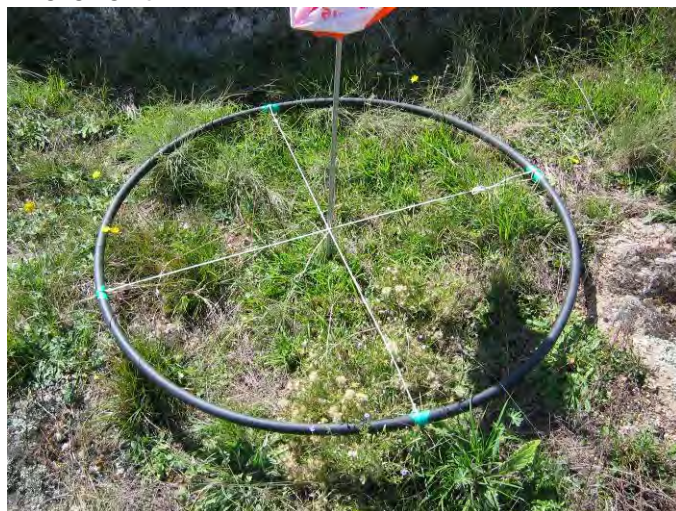
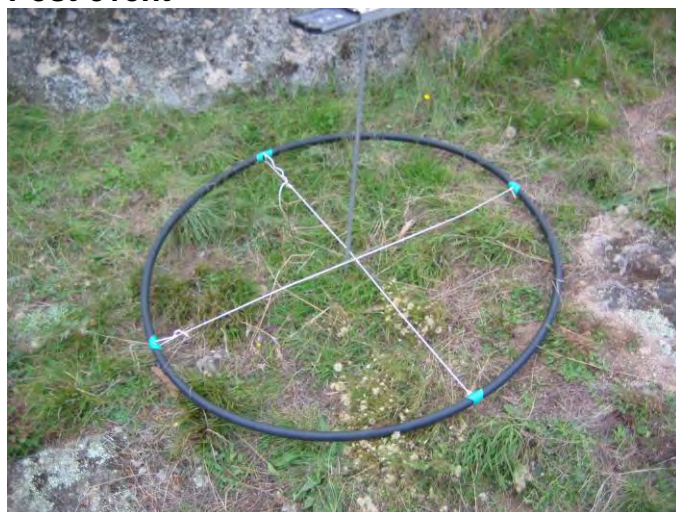
Control no: 168

Almost no post-event impact was evident. Further monitoring was considered unnecessary

Overall post-event impact: Minimal

Survey	Percentage cover					Comments
	Groundcover	Shrubs	Litter	Bare ground	Rock	
Pre-event	82	0	13	5	<1	Short pasture growth
Post-event	82	2	9	6	1	Minor new bare ground
One year						Not monitored
