APPENDIX.

CONTROL SITE PHOTOGRAPHS, VEGETATION COVER DATA AND SUMMARY ASSESSMENTS

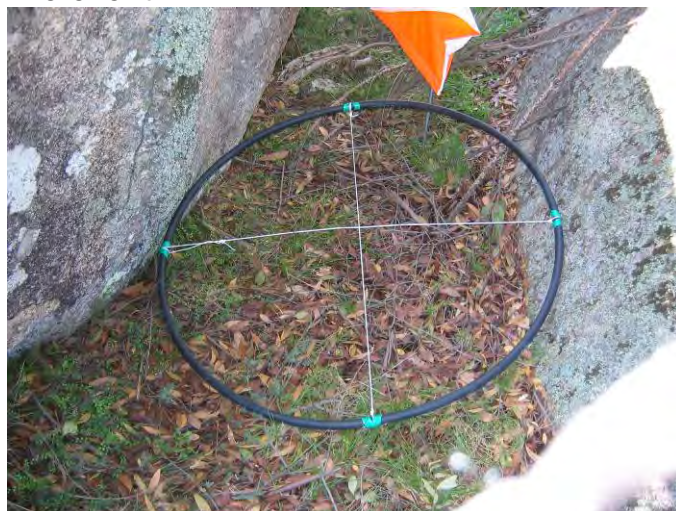
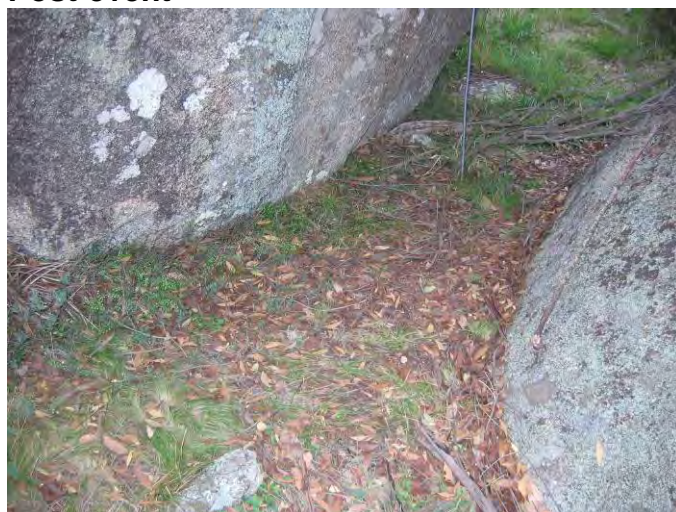
Control no: 170

While some flattening of litter and grass was evident after the event, there was no real impact. Further monitoring was considered unnecessary.

Overall post-event impact: Minimal

Survey	Percentage cover					Comments
	Groundcover	Shrubs	Litter	Bare ground	Rock	
Pre-event	24	0	72	4	<1	Low groundcover. High litter cover
Post-event	21	0	79	0	0	Minor or no trampling
One year						Not monitored
