APPENDIX.

CONTROL SITE PHOTOGRAPHS, VEGETATION COVER DATA AND SUMMARY ASSESSMENTS

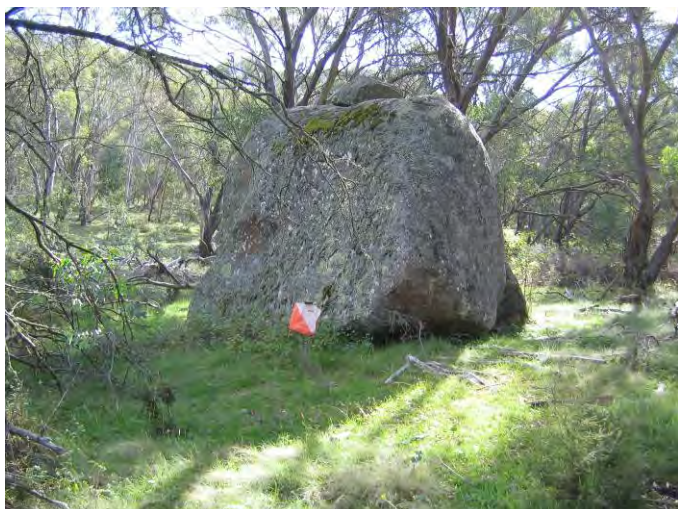
Control no: 106

Immediately following the event, there was some flattening of grass along the route past the control (mainly outside the quadrat) but no other impacts. Further monitoring was considered unnecessary.

Overall post-event impact: Minimal

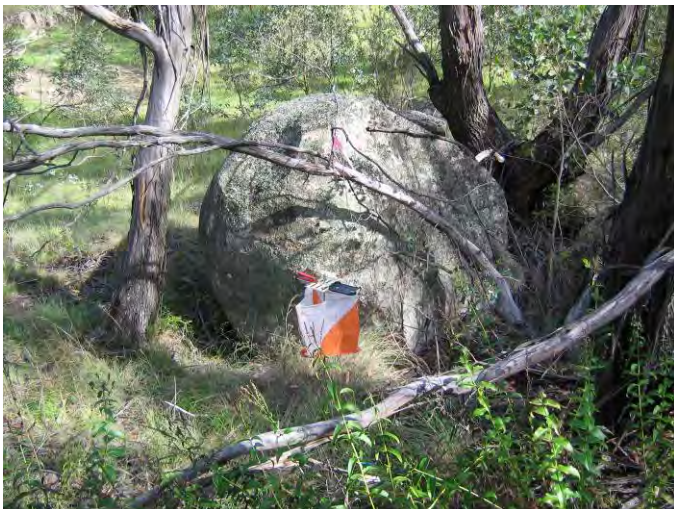
Control no. 114

There was some increase in bare ground following the event and an increase in litter cover, possibly due to litter movement from outside the quadrat. The increase in bare ground was more evident outside the quadrat. There was also obvious trampling of the grass.

After one year the groundcover had largely recovered with the areas of litter cover and bare ground reduced.

Overall post-event impact: Moderate
Overall one-year impact: Minor

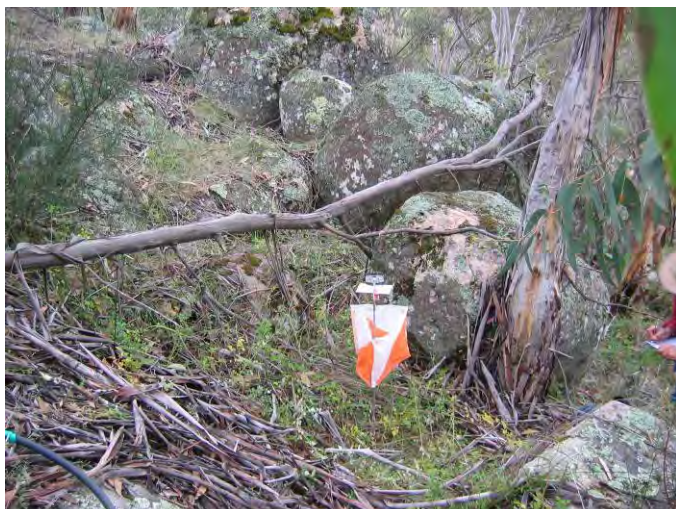
Control no: 116

Litter appeared to have moved downslope, covering groundcover and exposing an area of bare ground just outside the quadrat (not indicated in numerical results but visible in photograph). A native raspberry plant had gone. After one year, there was regrowth of the native raspberry and a thin cover of litter over the bare ground outside the quadrat.

Overall post-event impact: Moderate

Overall one-year impact: Minor

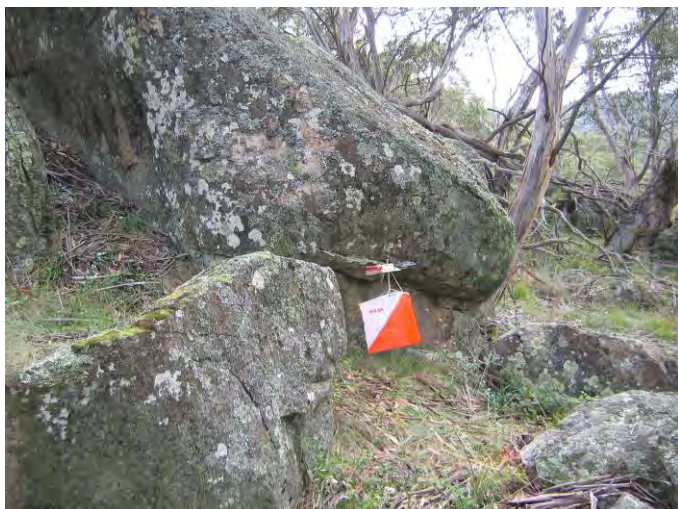
Control no: 117

Litter and small rocks had moved downhill within the quadrat. There was not much change within the quadrat, although the litter was flattened and the area of bare ground outside the quadrat increased. This bare ground was covered with leaf litter after one year. Lichen on the rock remained intact.

Overall post-event impact: Major
Overall one-year impact: Negligible

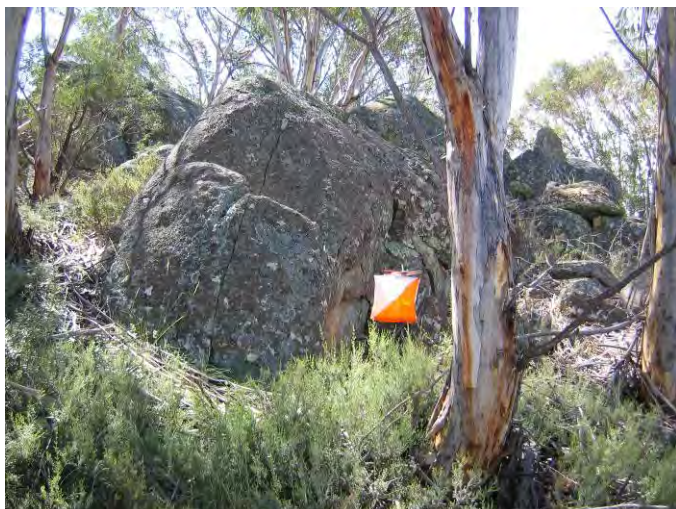
Control no: 120

There was some heath damage near the control and particularly downslope of the control (outside the quadrat), exposing areas of rock. Lichen on the rock remained intact.

After one year, there was partial recovery of the heath, although much of the disturbed area was covered with litter.

Overall post-event impact: Major
Overall one-year impact: Minor

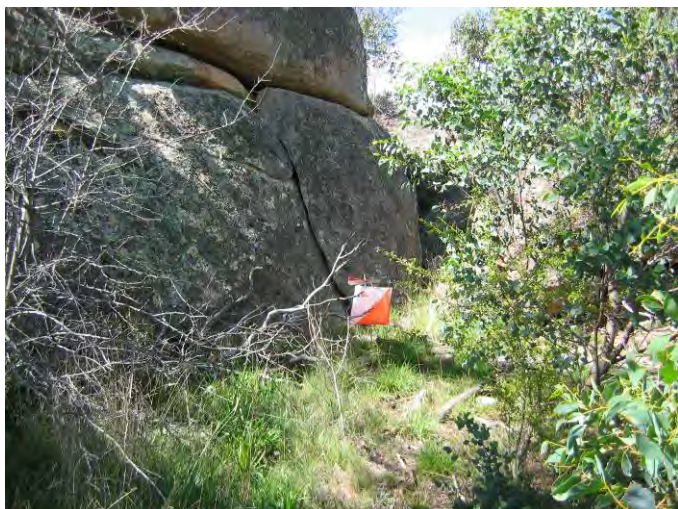
Control no: 122

There was an increase in bare ground immediately following the event, mainly as a result of reduced litter cover. This was evident both within the quadrat and outside it on the exit route.

After one year, the area of bare ground was reduced but it was still evident. There was increased regeneration of groundcover, mainly *Themeda*.

Overall post-event impact: Major

Overall one-year impact: Minor

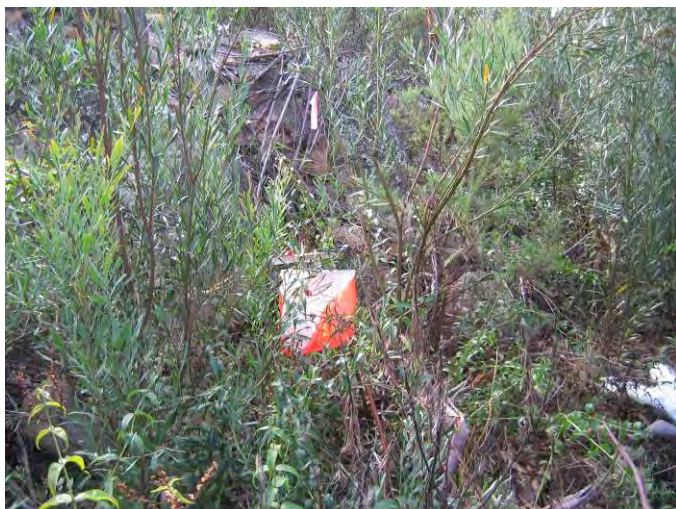
Control no: 123

Immediately following the event a small increase in bare ground due to litter loss was evident within the quadrat. More extensive litter disturbance was evident outside the quadrat, downslope on the exit route from the control.

After one year, this bare ground was covered with litter or groundcover, and there was further development of groundcover and shrubs in some of the litter areas.

Overall post-event impact: Moderate

Overall one-year impact: Minor

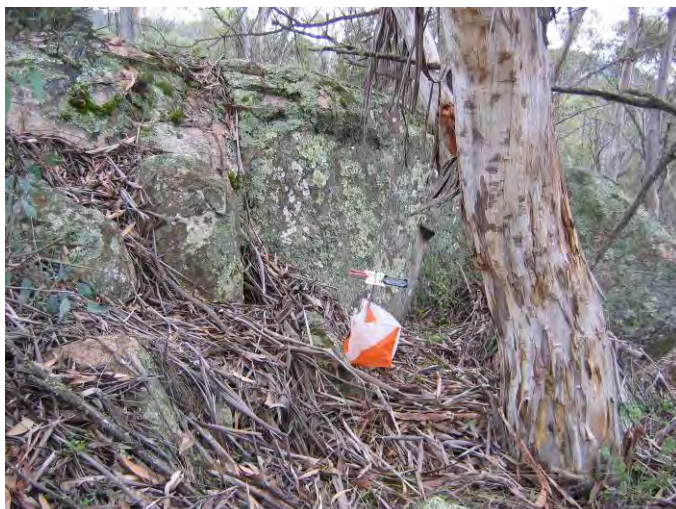
Control no: 128

This site was completely covered with litter prior to the event. That litter was trampled but remained generally intact, except for a small amount of bare ground. Minor lichen damage occurred on the rock. A deep litter cover had developed one year after the event.

There was obvious tracking down the hill into the control immediately after the event but this was not evident after one year.

Overall post-event impact: Minor
Overall one-year impact: Negligible

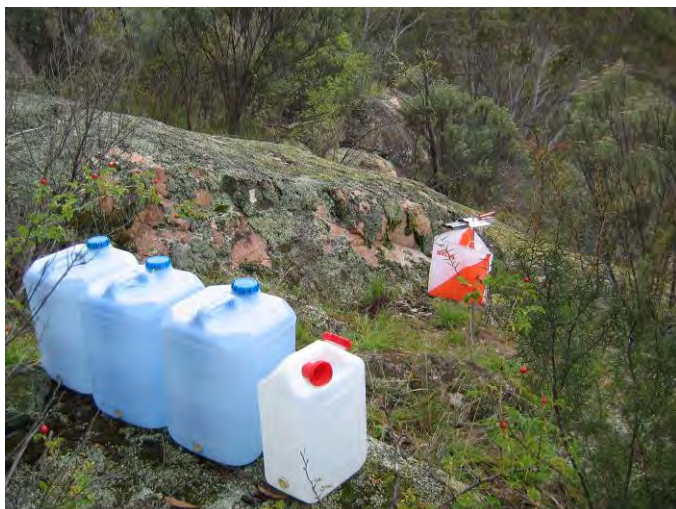
Control no: 129

There was obvious grass flattening on the routes in and out of the control following the event which resulted in a reduction in the area of groundcover and an increase in litter. Some small areas of bare ground developed just outside the circular quadrat. There was possibly some grass damage. There was minor damage to lichen on the rocks within the site, but most lichen remained intact.

After one year the grass had recovered, largely covering the bare spots, and the condition of the site was very similar to that prior to the event.

Overall post-event impact: Moderate
Overall one-year impact: Negligible

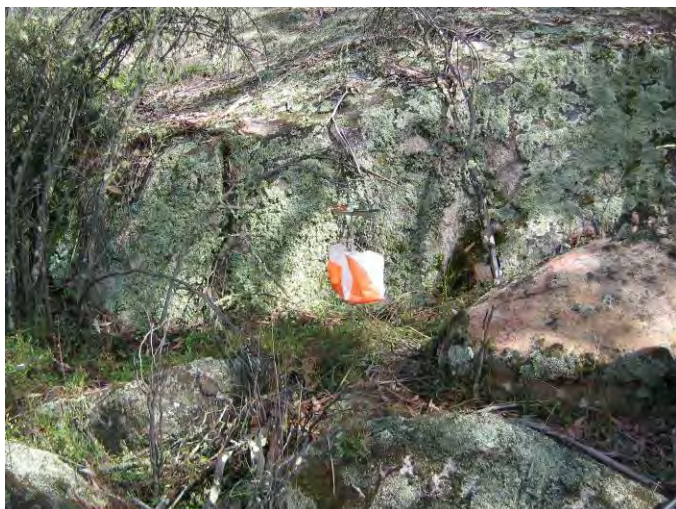
Control no: 132

The groundcover (grass) was flattened on the route out of the control and there was some movement of litter and a minor increase in bare ground. A large fallen branch had been moved into the quadrat.

After one year, there was dense regeneration of grass and forbs (especially sorrel) in areas of litter and bare ground.

Overall post-event impact: Moderate
Overall one-year impact: Negligible

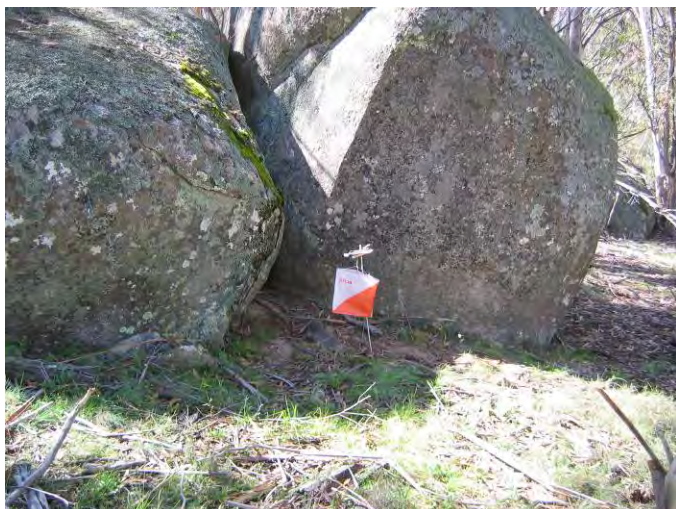
Control no: 133

This was one of the more disturbed control sites immediately following the event, with a significant increase in bare ground within areas of litter or groundcover, both within and outside the quadrat, some flattening of grass, and movement of sticks.

After one year, however, there was a light cover of leaf litter over most of the bare ground, and further movement of the sticks. Some disturbance of the site unrelated to the orienteering event occurred during that period as the marker peg had been pulled out and a stick with flagging tape had been broken.

Overall post-event impact: Major
Overall one-year impact: Minor

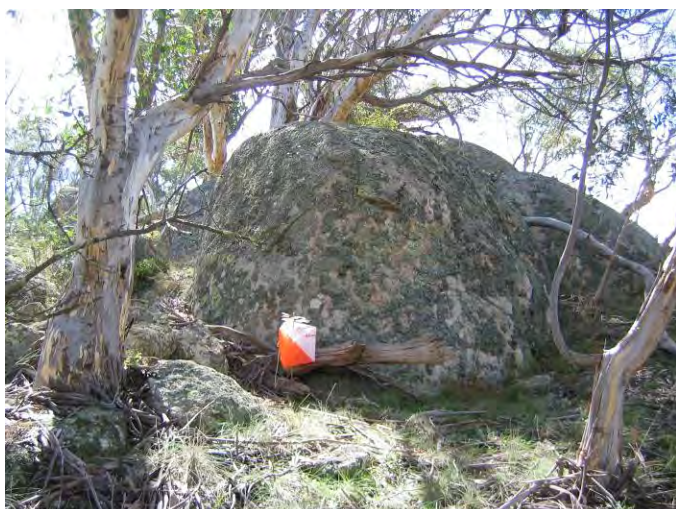
Control no: 134

Immediately after the event, the area of bare ground was increased due to loss of litter. Elsewhere the litter or grass was flattened, with some grass exposed possibly due to litter movement. Some flattening occurred also downhill of the control but this was relatively minor.

After one year, fresh litter had accumulated to eliminate the bare ground, and some grass and sorrel had regenerated.

Overall post-event impact: Moderate
Overall one-year impact: Negligible

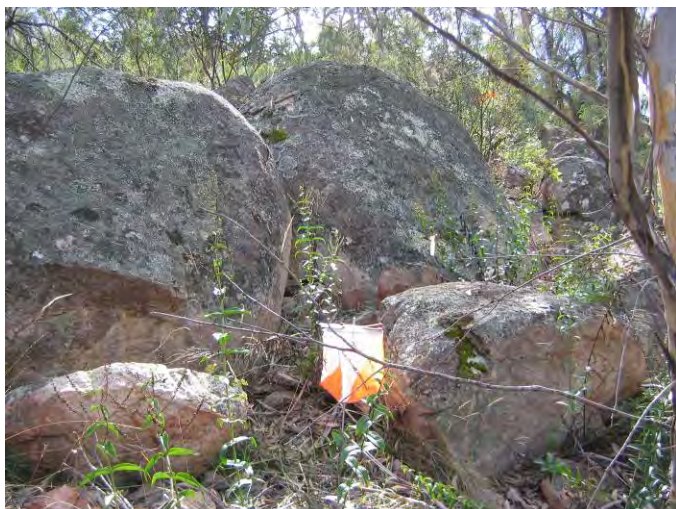
Control no: 138

The litter was flattened immediately after the event, but otherwise there was not much impact. Further monitoring was considered unnecessary.

Overall post-event impact: Minor

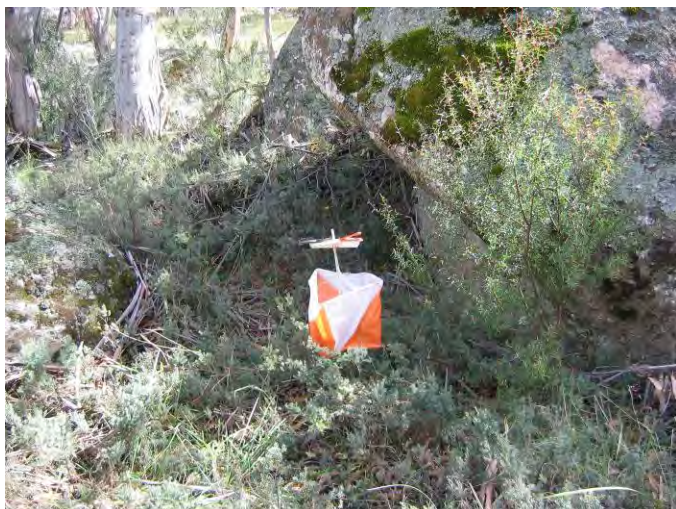
Control no: 144

Very minor damage occurred to the *Leucopogon* low shrub and litter and groundcover outside the quadrat was flattened, but there was a generally low level of impact immediately after the event.

The flattened area accumulated litter after one year and there was regeneration of groundcover. Otherwise not much further change was evident.

Overall post-event impact: Minor
Overall one-year impact: Negligible

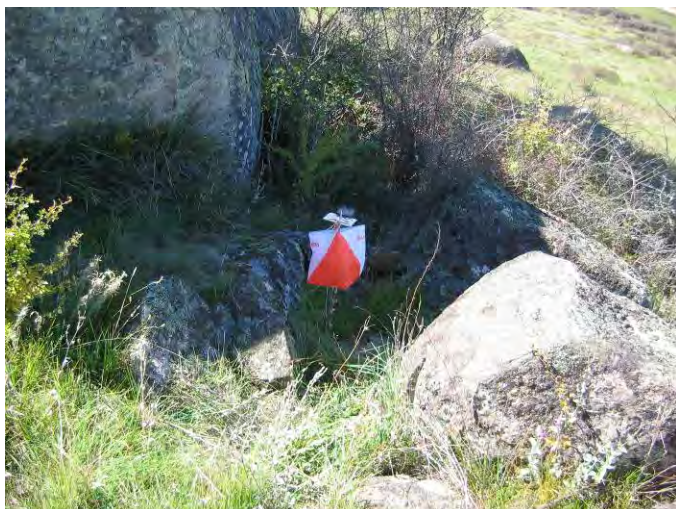
Control no: 145

The grass around the control was flattened but otherwise not damaged during the event, resulting in a rock being covered with thatch (measured as litter). Similar impacts were noted on the routes into and out of the control.

The situation was reversed after one year, with the grass regenerating and the rock becoming exposed. A stem of blackberry had grown over the control site from outside.

Overall post-event impact: Moderate
Overall one-year impact: Negligible

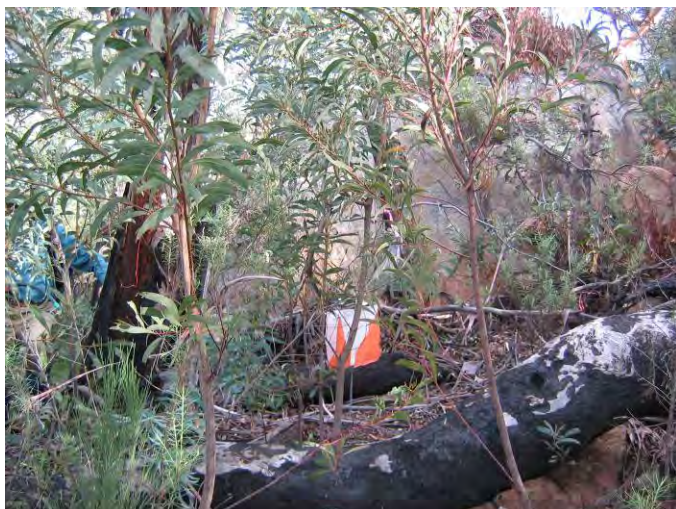
Control no: 146

Immediately following the event, there was some increase in bare ground, within and outside the quadrat due to litter disturbance. Elsewhere the litter was flattened, but remained in place.

After one year, the litter cover was restored with leaves and bark. A new wattle seedling had grown within the quadrat.

Overall post-event impact: Minor
Overall one-year impact: Negligible

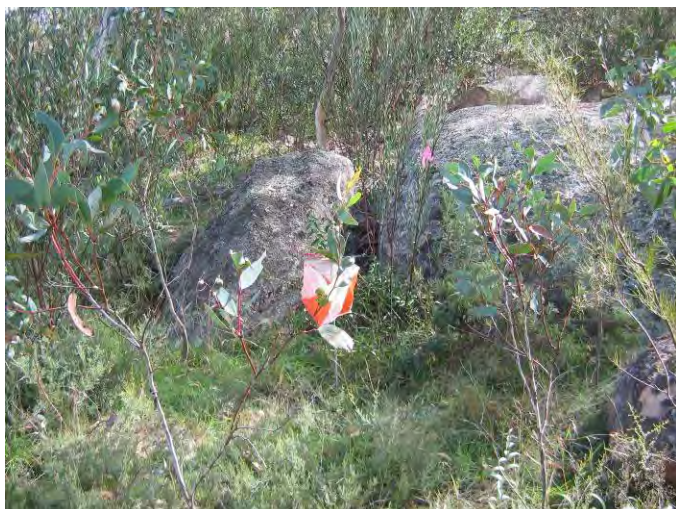
Control no: 147

Apart from some flattening of grass, no post-event impact was evident. Further monitoring was considered unnecessary.

Overall post-event impact: Minimal

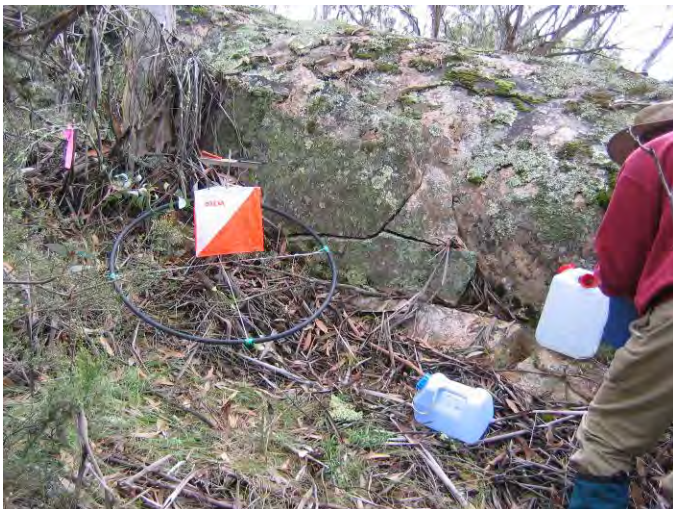
Control no: 148

There was an increase in bare ground, but this was virtually all in an area that was previously litter. Some of the litter was scattered over an area that was previously rock. Lichen on the rocks remained largely intact. Some of the bare ground and litter areas were covered with grass after one year, with litter redistributed over most of the rocks.

Litter was flattened near the drinks located downhill of the control, but maintained its cover. That area remained covered with litter after one year.

Overall post-event impact: Moderate
Overall one-year impact: Negligible

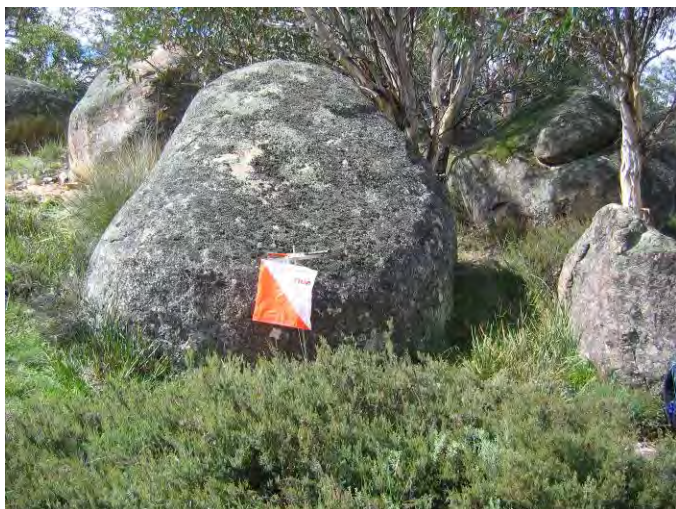
Control no: 155

The main impact immediately following the event was partial flattening of the heath. This impact was less severe than at some other controls, and the heath appeared to have recovered fully after one year.

Overall post-event impact: Moderate
Overall one-year impact: Negligible

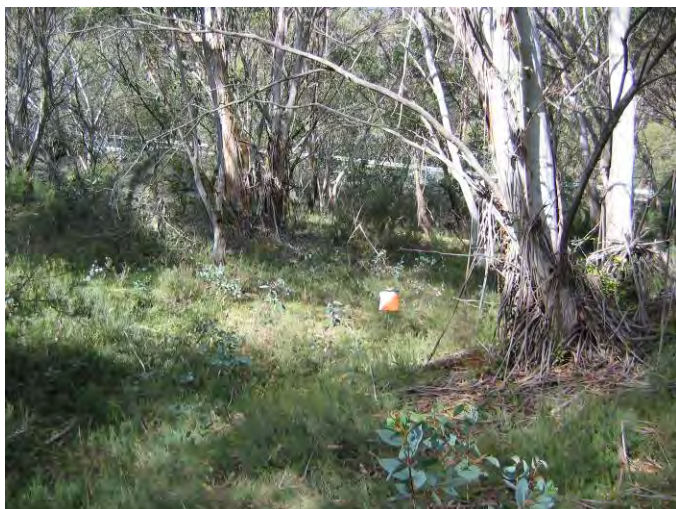
Control no: 157

Immediately after the event there was much flattening of the low heath (*Mirbelia*), as well as disturbance of litter to create bare ground, mainly outside the quadrat.

The flattened heath had fully recovered after one year, and the areas of bare ground had acquired a light cover of litter.

Overall post-event impact: Moderate
Overall one-year impact: Negligible

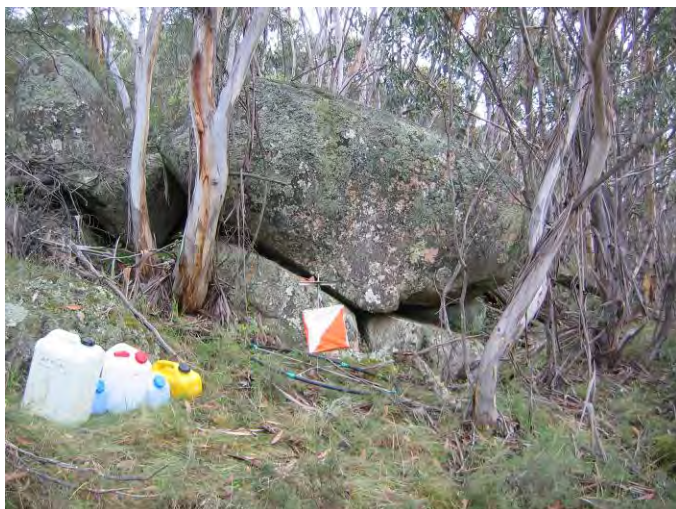
Control no: 160

Within and immediately around the monitoring site itself, there was minor impact immediately after the event, with just some slight disturbance to litter. This was a drinks control and trampling of grass below the drinks location was evident, although there was not much damage. There was no sign of disturbance after one year.

The route out of the control to the south showed obvious litter disturbance and possibly some minor grass damage. This had fully recovered with some grass growth after one year.

Overall post-event impact: Minor
Overall one-year impact: Negligible

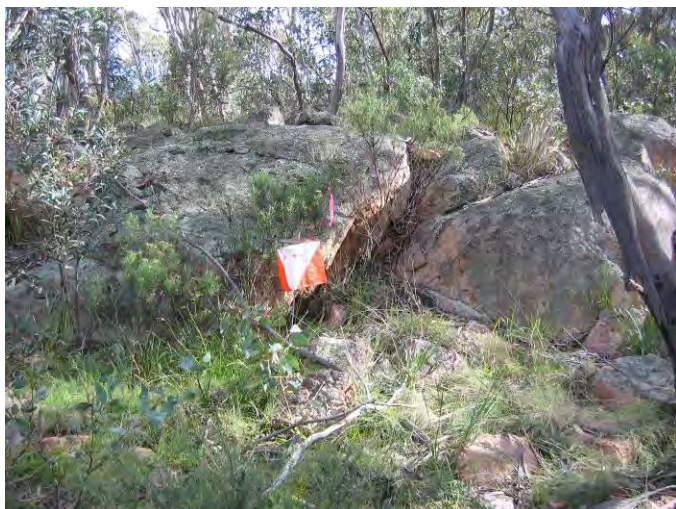
Control no: 161

Immediately following the event, the grass was flattened around the control, increasing the exposure of the rocks, but otherwise there was no impact. Some litter disturbance was evident 3 to 4 metres from the control. Further monitoring was considered unnecessary.

Overall post-event impact: Minor

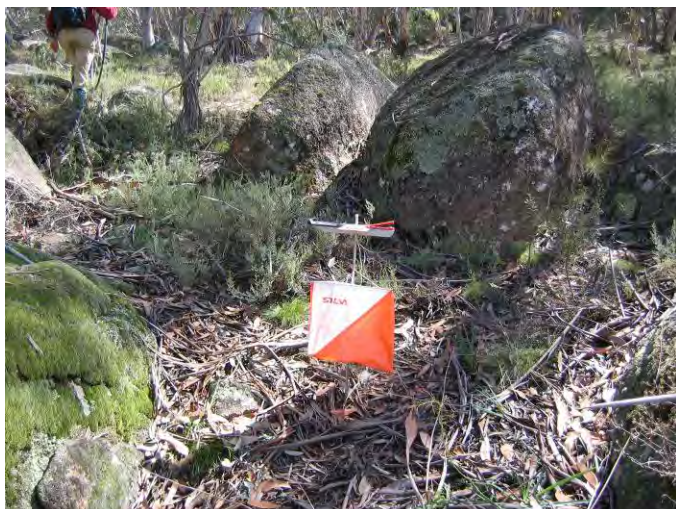
Control no: 166

During the event, litter was pushed from upslope of the control (outside the quadrat) to cover some bare ground and rock within the quadrat, and expose bare ground outside it. There was no disturbance downhill of the control, suggesting that runners generally arrived and departed from above.

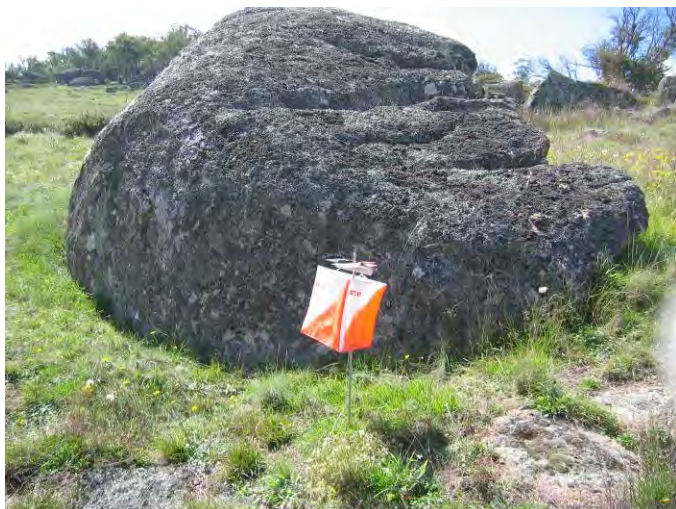
Control no: 168

Almost no post-event impact was evident. Further monitoring was considered unnecessary

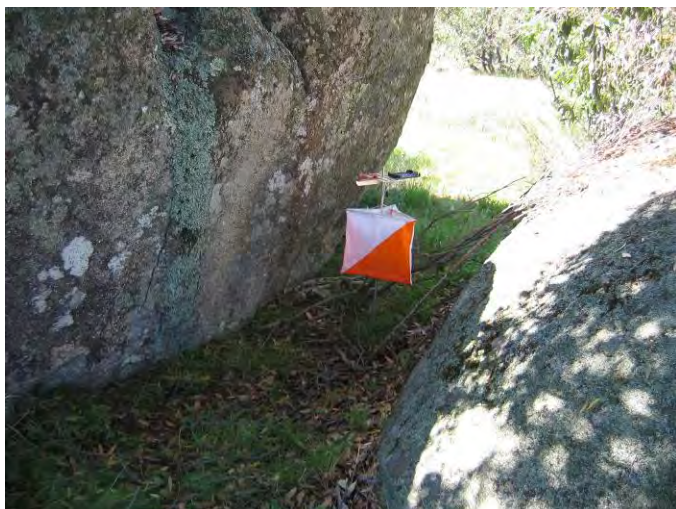
Control no: 170

While some flattening of litter and grass was evident after the event, there was no real impact. Further monitoring was considered unnecessary.
